Access Compliance Report

Public Rights-of-Way

(Curb Ramps)

Intersection ID: 14445	Main Street: ALBEMARLE_RD	Cross Street: MANCHESTER_LN	Location: SE
ADA ID: 7B5EA69627A5	Ramp Type: Perp	Initial Pass/Fail: Fail	Overall Compliance: No
Severity Score: 13.75			
Codes/Mitigation Info/Possible Solution		Field Measurements/Component Compliance

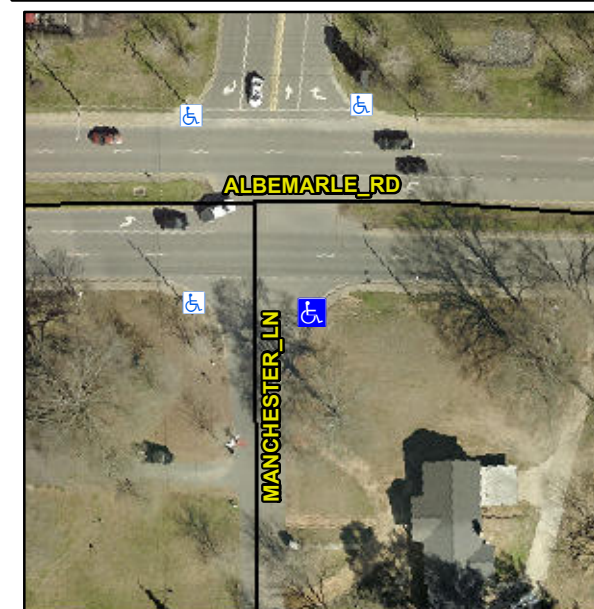
Not Found, R304.2.2, R304.5.3

Compliance	Description	Data	Compliance	Description	Data
N/A	Ramp Length (in)	57.0	No	Ramp Slope (%)	8.4
Yes	Ramp Width (in)	48.0	No	Ramp XSlope (%)	4.1
N/A	Flare Type LT	N/A	N/A	Flare Type RT	N/A
N/A	Flare Slope LT (%)	N/A	N/A	Flare Slope RT (%)	N/A
N/A	Flare Traversable LT?	N/A	N/A	Flare Traversable RT?	N/A
N/A	Landing Length (in)	N/A	N/A	DWS Provided?	N/A
N/A	Landing Width (in)	N/A	N/A	DWS Contrast?	N/A
N/A	Landing Slope (%)	N/A	N/A	DWS Length (in)	N/A
N/A	Landing X Slope (%)	N/A	N/A	DWS Full Width?	N/A
N/A	Landing Curb? (Y/N)	N/A	N/A	DWS Offset (in)	N/A
N/A	Shared Landing?	N/A			
N/A	Gutter Ponding?	N/A	N/A	Gutter Slope (%)	N/A
N/A	Gutter Lip Ht (in)	N/A	N/A	Gutter X Slope (%)	N/A
N/A	Painted X Walk1?	No	N/A	Painted X Walk2?	N/A
	X Walk 1 Direction	To W		X Walk 2 Direction	N/A
N/A	X Walk 1 Width (in)	N/A	N/A	X Walk 2 Width (in)	N/A
	X Walk 1 Slope (%)	3.7		X Walk 2 Slope (%)	N/A
	X Walk 1 X Slope (%)	3.1		X Walk 2 X Slope (%)	N/A

N/A	Ramp inside XWalk1?	N/A	N/A	Ramp inside XWalk2?	N/A
	Road Slope (%)	N/A	N/A	Clear Space?	N/A
	Road X Slope (%)	N/A	N/A	Clear Space to XWalk (in)	N/A
N/A	Any Obstructions?	N/A	N/A	Storm Grate/Utility Hazard?	N/A
	Obstruction Type			Storm Grate/Utility Type	
		N/A			N/A
			Yes	Surface Condition? (G/P)	Good

Possible Solutions:

Remove & Replace Entire Ramp.

Total Cost: \$ 1850.00
