# Access Compliance Report

## Public Rights-of-Way

### (Curb Ramps)

| Intersection ID: 20057 | Main Street: ASSEMBLY_ST | Cross Street: BULFINCH_RD | Location: NW |

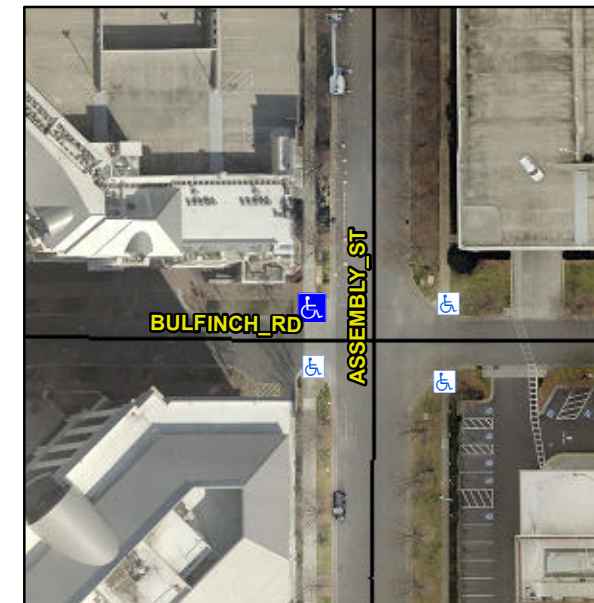
**R304.5.3, R304.2.2-Perp, R304.3.2-Para**

| Compliance | Description | Data | Compliance | Description | Data |
|---|---|---|---|---|---|
| Yes | Ramp Width (in) | 48.0 | No | BlendTrans XSlope (%) | 3.0 |
| No | Landing Slope (%) | 2.5 | Yes | DWS Length (in) | 24.0 |
| Yes | Gutter Lip Ht (in) | 0.0 | No | Gutter X Slope (%) | 2.2 |

**Remove & Replace Curb Ramp With Two New Directional Ramps or Equivalent. Remove & Replace Gutter.**

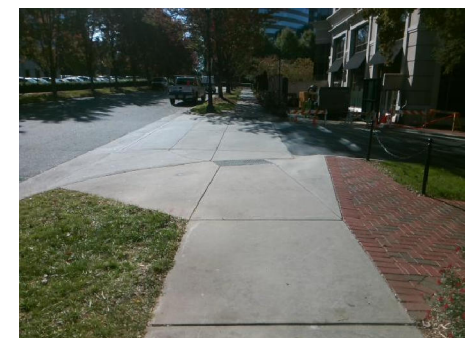
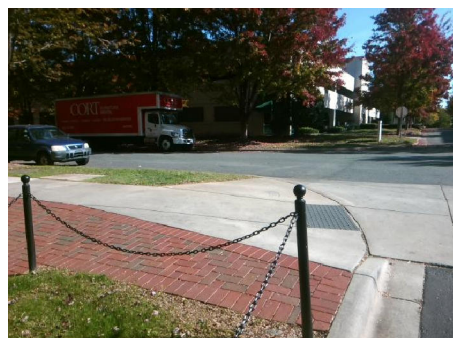
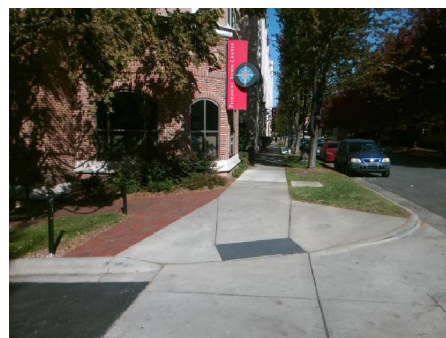
Street 1 Name BULFINCH RD  
 Stop Condition-Street 1 StopSign  
 Street 2 Name ASSEMBLY ST  
 Stop Condition-Street 2 None
