# Access Compliance Report

## Public Rights-of-Way

### (Curb Ramps)

| Intersection ID: 14515 | Main Street: QUEENS_RD | Cross Street: S_CASWELL_RD | Location: S |

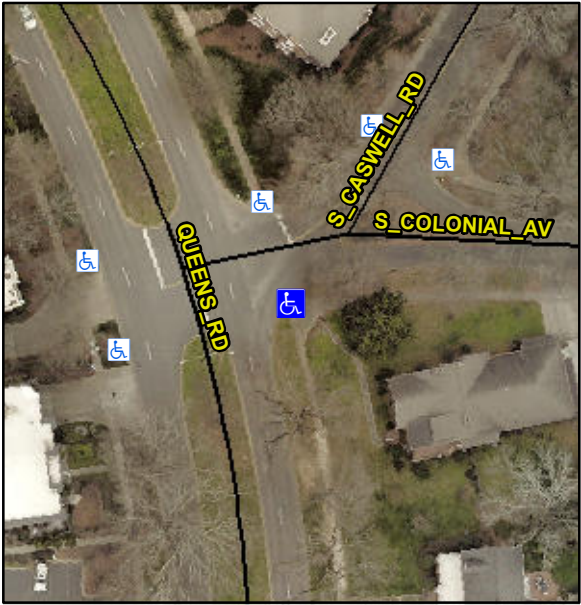
| ADA ID: 7B6D5DA385D8 | Ramp Type: PerpDiag | Initial Pass/Fail: Fail | Overall Compliance: No |
| | | | Severity Score: 13.75 |

| Codes/Mitigation Info/Possible Solution | | | Field Measurements/Component Compliance | | |
|---|---|--|---|---|---|
| <p>Surveyor Notes:</p> <p>N/A</p> <p>PROW/ADA:</p> <p>R304.2.2, R304.5.3</p> | | | N/A | Flare Type RT | N/A |

| Codes/Mitigation Info/Possible Solution | | | Field Measurements/Component Compliance | | |
|---|---|--|---|---|---|
| | Remove & Replace Curb Ramp With Two New Directional Ramps or Equivalent. | | N/A | Ramp Length (in) | 66.0 |
