# Access Compliance Report

## Public Rights-of-Way

### (Curb Ramps)

Intersection ID: N/A	Main Street: ELKIN_LN	Cross Street: KILBORNE_DR	Location: NW
ADA ID: 7B715D1308A4	Ramp Type: Directional1	Initial Pass/Fail: Fail	Overall Compliance: No
		Severity Score: 12.5

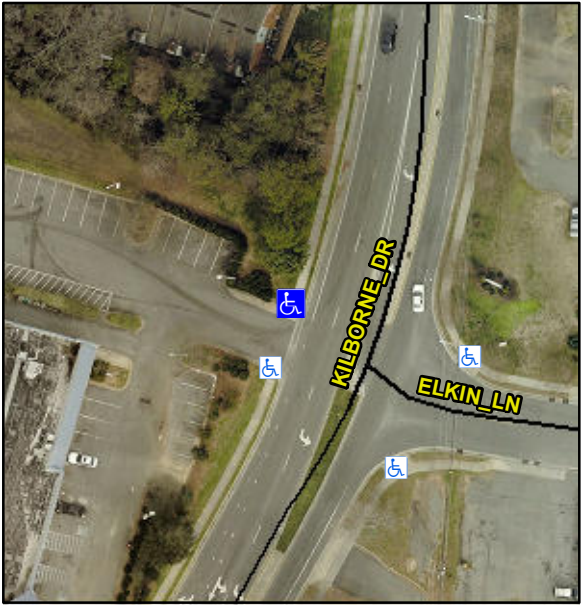
Possible Solutions:		<b>Compliance</b>	<b>Description</b>	<b>Data</b>
	<b>Remove &amp; Replace Entire Ramp.</b>		N/A	Ramp Length (in)	121.0
			Yes	Ramp Width (in)	60.0
			No	Ramp Slope (%)	9.7
			Yes	Ramp XSlope (%)	1.4
			N/A	Flare Type LT	N/A
			N/A	Flare Slope LT (%)	N/A
			N/A	Flare Traversable LT?	N/A
			N/A	Flare Type RT	N/A
			N/A	Flare Slope RT (%)	0.0
<p>Surveyor Notes:</p> <p><b>N/A</b></p>			N/A	Grade Break?	N/A
			N/A	Grade Break Slope (%)	0.0
			N/A	Grade Break XSlope (%)	0.0
			N/A	Flare Type RT	N/A
			N/A	Flare Slope RT (%)	0.0
			N/A	Flare Traversable RT?	N/A
			N/A	DWS Provided?	N/A
			N/A	DWS Contrast?	N/A
			N/A	DWS Length (in)	N/A
			N/A	DWS Full Width?	N/A
<p>PROW/ADA:</p> <p><b>R304.2.2</b></p>			N/A	DWS Offset LT (in)	N/A
			N/A	DWS Offset RT (in)	N/A
			N/A	Gutter Slope (%)	N/A
			N/A	Gutter Lip Ht (in)	N/A

N/A	Gutter X Slope (%)	N/A
			N/A	Road Slope (%)	0.6
			N/A	Road X Slope (%)	8.7
			N/A	Clear Space?	N/A
			N/A	Clear Space to XWalk (in)	N/A
			N/A	Storm Grate/Utility Hazard?	N/A
<p>Total Cost:</p> <p><b>\$ 1600.00</b></p>			N/A	Storm Grate/Utility Type	N/A
			N/A	Obstruction Type	N/A
			N/A	Surface Condition? (G/P)	Good
			N/A	Curb Slope (%)	2.2
			N/A		
			N/A		
			N/A		
			N/A		
			N/A		
			N/A
