Access Compliance Report

Public Rights-of-Way

(Curb Ramps)

Intersection ID: 54374	Main Street: GRIER_RD	Cross Street: OLD_CONCORD_RD	Location: S
ADA ID: 7B71A0742DAD	Ramp Type: Perp	Initial Pass/Fail: Fail	Overall Compliance: No
Severity Score: 10			
Codes/Mitigation Info/Possible Solution		Field Measurements/Component Compliance

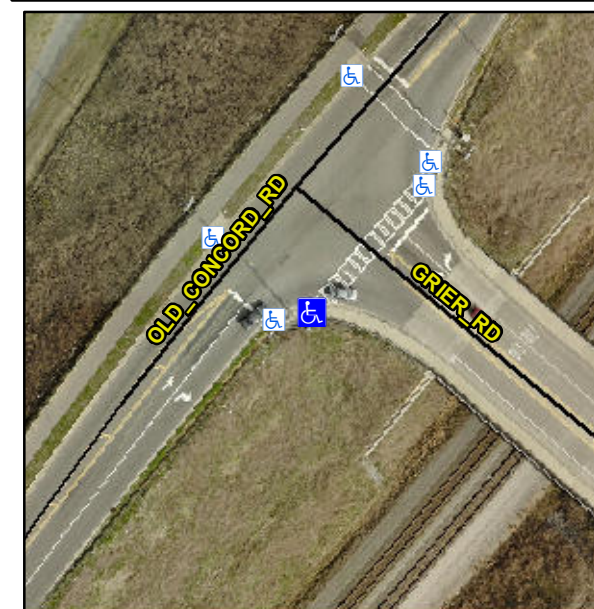
Compliance	Description	Data	Compliance	Description	Data
N/A	Ramp Length (in)	83.5	Yes	Ramp Slope (%)	6.3
No	Ramp Width (in)	47.0	No	Ramp XSlope (%)	2.5
N/A	Flare Type LT	N/A	N/A	Flare Type RT	N/A
N/A	Flare Slope LT (%)	N/A	N/A	Flare Slope RT (%)	N/A
N/A	Flare Traversable LT?	N/A	N/A	Flare Traversable RT?	N/A
N/A	Landing Length (in)	N/A	N/A	DWS Provided?	N/A
N/A	Landing Width (in)	N/A	N/A	DWS Contrast?	N/A
N/A	Landing Slope (%)	N/A	N/A	DWS Length (in)	N/A
N/A	Landing X Slope (%)	N/A	N/A	DWS Full Width?	N/A
N/A	Landing Curb? (Y/N)	N/A	N/A	DWS Offset (in)	N/A
N/A	Shared Landing?	N/A			
N/A	Gutter Ponding?	N/A	N/A	Gutter Slope (%)	N/A
N/A	Gutter Lip Ht (in)	N/A	N/A	Gutter X Slope (%)	N/A
N/A	Painted X Walk1?	Yes	N/A	Painted X Walk2?	N/A
	X Walk 1 Direction	To NE		X Walk 2 Direction	N/A
N/A	X Walk 1 Width (in)	104.0	N/A	X Walk 2 Width (in)	N/A
	X Walk 1 Slope (%)	1.0		X Walk 2 Slope (%)	N/A
	X Walk 1 X Slope (%)	0.3		X Walk 2 X Slope (%)	N/A

N/A	Ramp inside XWalk1?	Yes	N/A	Ramp inside XWalk2?	N/A
	Road Slope (%)	N/A	N/A	Clear Space?	N/A
	Road X Slope (%)	N/A	N/A	Clear Space to XWalk (in)	N/A
N/A	Any Obstructions?	N/A	N/A	Storm Grate/Utility Hazard?	N/A
	Obstruction Type			Storm Grate/Utility Type	
		N/A			N/A
		Yes		Surface Condition? (G/P)	Good

Possible Solutions:

Remove & Replace Entire Ramp.
