# Access Compliance Report

## Public Rights-of-Way

### (Curb Ramps)

Intersection ID: 48600	Main Street: GRANDIFLORA_DR	Cross Street: N/A	Location: NE
ADA ID: 7B7848276EDA	Ramp Type: Perp	Initial Pass/Fail: Fail	Overall Compliance: No
Severity Score: 1.25			
Codes/Mitigation Info/Possible Solution		Field Measurements/Component Compliance

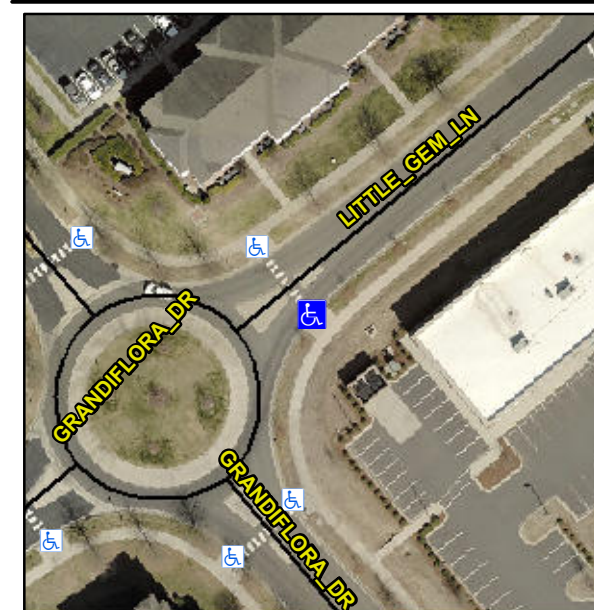
**Not Found, R304.5.3**

Compliance	Description	Data	Compliance	Description	Data
N/A	Ramp Length (in)	96.0	Yes	Ramp Slope (%)	5.9
Yes	Ramp Width (in)	50.0	No	Ramp XSlope (%)	2.3
N/A	Flare Type LT	N/A	N/A	Flare Type RT	N/A
N/A	Flare Slope LT (%)	N/A	N/A	Flare Slope RT (%)	N/A
N/A	Flare Traversable LT?	N/A	N/A	Flare Traversable RT?	N/A
N/A	Landing Length (in)	N/A	N/A	DWS Provided?	N/A
N/A	Landing Width (in)	N/A	N/A	DWS Contrast?	N/A
N/A	Landing Slope (%)	N/A	N/A	DWS Length (in)	N/A
N/A	Landing X Slope (%)	N/A	N/A	DWS Full Width?	N/A
N/A	Landing Curb? (Y/N)	N/A	N/A	DWS Offset (in)	N/A
N/A	Shared Landing?	N/A			
N/A	Gutter Ponding?	N/A	N/A	Gutter Slope (%)	N/A
N/A	Gutter Lip Ht (in)	N/A	N/A	Gutter X Slope (%)	N/A
N/A	Painted X Walk1?	Yes	N/A	Painted X Walk2?	N/A
	X Walk 1 Direction	To NW		X Walk 2 Direction	N/A
N/A	X Walk 1 Width (in)	54.5	N/A	X Walk 2 Width (in)	N/A
	X Walk 1 Slope (%)	2.8		X Walk 2 Slope (%)	N/A
	X Walk 1 X Slope (%)	3.1		X Walk 2 X Slope (%)	N/A

**Remove & Replace Entire Ramp.**

Total Cost: \$ 1850.00

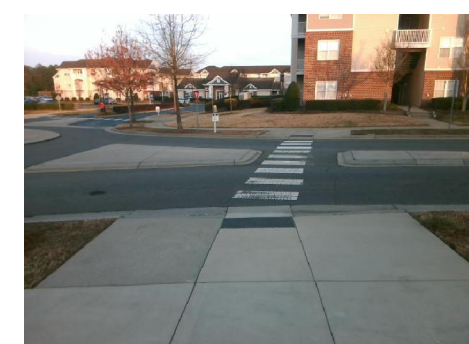
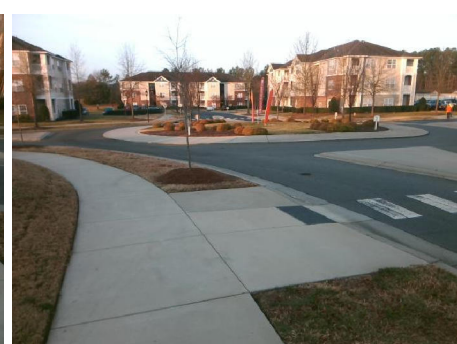
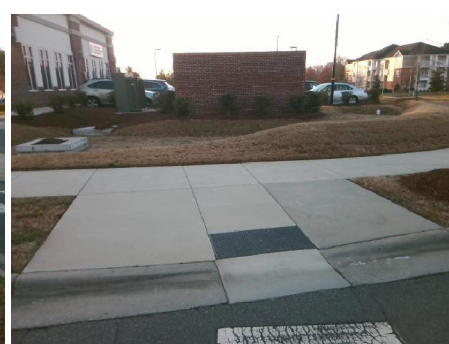
N/A	Ramp inside XWalk1?	Yes	N/A	Ramp inside XWalk2?	N/A
	Road Slope (%)	N/A	N/A	Clear Space?	N/A
	Road X Slope (%)	N/A	N/A	Clear Space to XWalk (in)	N/A
N/A	Any Obstructions?	N/A	N/A	Storm Grate/Utility Hazard?	N/A
	Obstruction Type			Storm Grate/Utility Type	
		N/A			N/A
		Yes		Surface Condition? (G/P)	Good
