Access Compliance Report

Public Rights-of-Way

(Curb Ramps)

Intersection ID: 30319	Main Street: HUNTER_FOREST_CT	Cross Street: HIDDEN_FOREST_DR	Location: NW
ADA ID: 7B7A8ADDC7E9	Ramp Type: PerpDiag	Initial Pass/Fail: Pass	Overall Compliance: No
Severity Score: 17.5			
Codes/Mitigation Info/Possible Solution		Field Measurements/Component Compliance

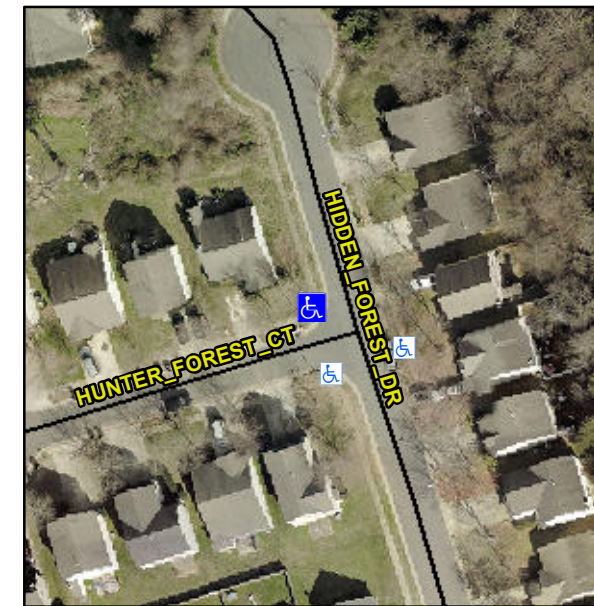
Compliance	Description	Data	Compliance	Description	Data
N/A	Ramp Length (in)	46.5	Yes	Ramp Slope (%)	7.0
Yes	Ramp Width (in)	48.0	Yes	Ramp XSlope (%)	1.4
N/A	Flare Type LT	Sloped	N/A	Flare Type RT	N/A
N/A	Flare Slope LT (%)	4.4	N/A	Flare Slope RT (%)	4.2
N/A	Flare Traversable LT?	No	N/A	Flare Traversable RT?	No
No	Landing Length (in)	46.0	No	DWS Provided?	No
Yes	Landing Width (in)	48.0	N/A	DWS Contrast?	No
No	Landing Slope (%)	4.6	N/A	DWS Length (in)	N/A
Yes	Landing X Slope (%)	0.7	N/A	DWS Full Width?	No
N/A	Landing Curb? (Y/N)	No	N/A	DWS Offset (in)	N/A
N/A	Shared Landing?	No			
Yes	Gutter Ponding?	No	Yes	Gutter Slope (%)	2.6
No	Gutter Lip Ht (in)	0.5	Yes	Gutter X Slope (%)	0.0
N/A	Painted X Walk1?	No	N/A	Painted X Walk2?	No
	X Walk 1 Direction	To S		X Walk 2 Direction	To E
N/A	X Walk 1 Width (in)	N/A	N/A	X Walk 2 Width (in)	N/A
	X Walk 1 Slope (%)	2.4		X Walk 2 Slope (%)	4.5
	X Walk 1 X Slope (%)	2.4		X Walk 2 X Slope (%)	0.3

N/A	Ramp inside XWalk1?	N/A	N/A	Ramp inside XWalk2?	N/A
	Road Slope (%)	1.3	N/A	Clear Space?	Yes
	Road X Slope (%)	0.2	N/A	Clear Space to XWalk (in)	N/A
Yes	Any Obstructions?	No	Yes	Storm Grate/Utility Hazard?	No
	Obstruction Type			Storm Grate/Utility Type	
		N/A			N/A
		Yes		Surface Condition? (G/P)	Good

Remove & Replace Curb Ramp With Two New Directional Ramps or Equivalent.
