# Access Compliance Report

## Public Rights-of-Way

### (Curb Ramps)

| Intersection ID: 49395 | Main Street: ROMANA_RED_LN | Cross Street: DAMASCUS_ST | Location: SE |

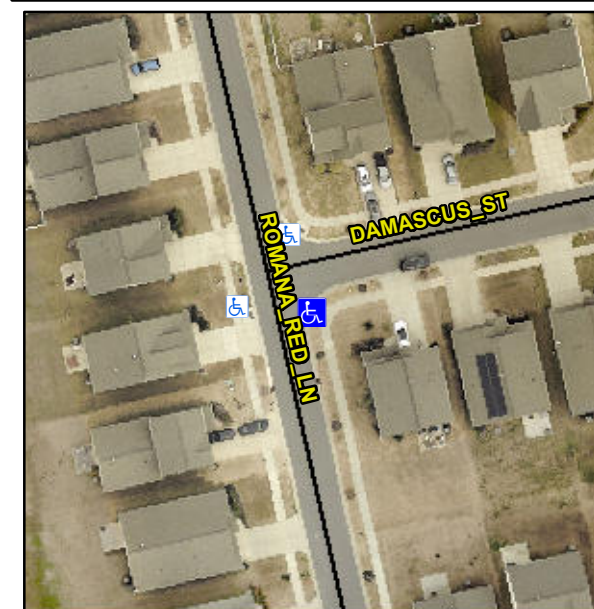
| Severity Score: 12.75 | | | |

**Not Found, R304.5.3, R305.2, R302.7.2, R304.5.4**

| Compliance | Description | Data | Compliance | Description | Data |
|---|---|---|---|---|---|
| N/A | Ramp Length (in) | 73.0 | Yes | Ramp Slope (%) | 6.3 |
| Yes | Ramp Width (in) | 48.0 | No | Ramp XSlope (%) | 2.6 |
| No | Landing X Slope (%) | 4.6 | Yes | DWS Full Width? | Yes |
| N/A | Landing Curb? (Y/N) | No | No | DWS Offset (in) | 5.5 |
| Yes | Gutter Ponding? | No | No | Gutter Slope (%) | 10.1 |
| No | Gutter Lip Ht (in) | 0.5 | No | Gutter X Slope (%) | 5.0 |

**Remove & Replace Curb Ramp With Two New Directional Ramps or Equivalent. Remove & Replace Gutter.**

Total Cost: \$ 3950.00
