Access Compliance Report

Public Rights-of-Way

(Curb Ramps)

Intersection ID: 10193	Main Street: N_GRAHAM_ST	Cross Street: WOLFBERRY_ST	Location: E
ADA ID: 7B80414B2719	Ramp Type: Perp	Initial Pass/Fail: Fail	Overall Compliance: No
Severity Score: 25			
Codes/Mitigation Info/Possible Solution		Field Measurements/Component Compliance

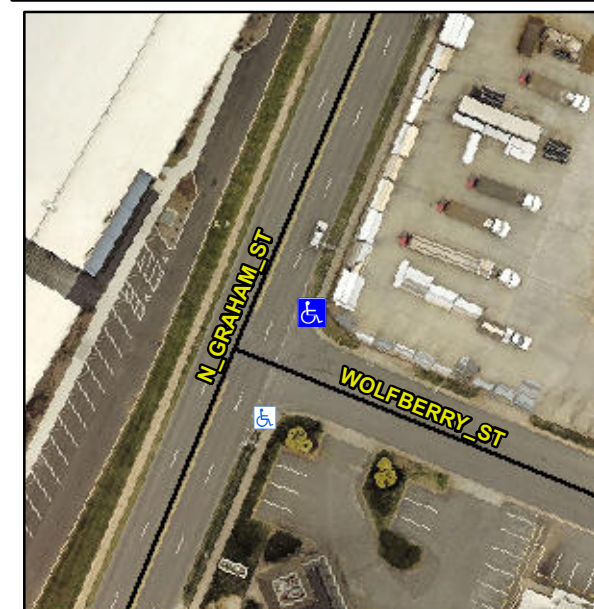
Not Found, R304.2.2

Compliance	Description	Data	Compliance	Description	Data
N/A	Ramp Length (in)	49.0	No	Ramp Slope (%)	13.2
Yes	Ramp Width (in)	65.5	Yes	Ramp XSlope (%)	0.8
N/A	Flare Type LT	N/A	N/A	Flare Type RT	N/A
N/A	Flare Slope LT (%)	N/A	N/A	Flare Slope RT (%)	N/A
N/A	Flare Traversable LT?	N/A	N/A	Flare Traversable RT?	N/A
N/A	Landing Length (in)	N/A	N/A	DWS Provided?	N/A
N/A	Landing Width (in)	N/A	N/A	DWS Contrast?	N/A
N/A	Landing Slope (%)	N/A	N/A	DWS Length (in)	N/A
N/A	Landing X Slope (%)	N/A	N/A	DWS Full Width?	N/A
N/A	Landing Curb? (Y/N)	N/A	N/A	DWS Offset (in)	N/A
N/A	Shared Landing?	N/A			
N/A	Gutter Ponding?	N/A	N/A	Gutter Slope (%)	N/A
N/A	Gutter Lip Ht (in)	0.5	N/A	Gutter X Slope (%)	N/A
N/A	Painted X Walk1?	No	N/A	Painted X Walk2?	N/A
	X Walk 1 Direction	To SW		X Walk 2 Direction	N/A
N/A	X Walk 1 Width (in)	N/A	N/A	X Walk 2 Width (in)	N/A
	X Walk 1 Slope (%)	0.4		X Walk 2 Slope (%)	N/A
	X Walk 1 X Slope (%)	0.8		X Walk 2 X Slope (%)	N/A

Remove & Replace Entire Ramp.
