# Access Compliance Report

## Public Rights-of-Way

| Intersection ID: 53980 | Main Street: ABENDEGO_RD | Cross Street: SUNBURST_LN | Location: | E |
| ADA ID: 7B8946E6F695 | Ramp Type: BlendTrans1 | Initial Pass/Fail: Fail | Overall Compliance: No | Severity Score: 10 |

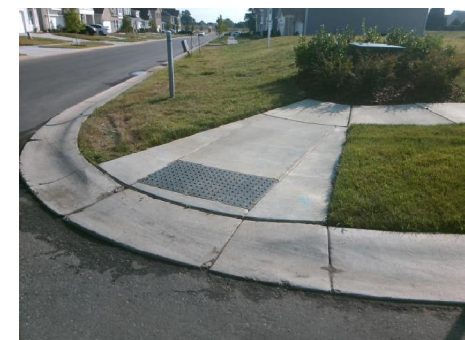
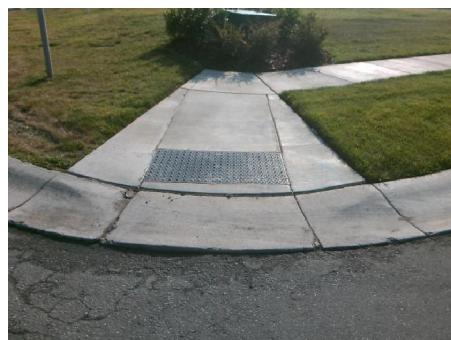
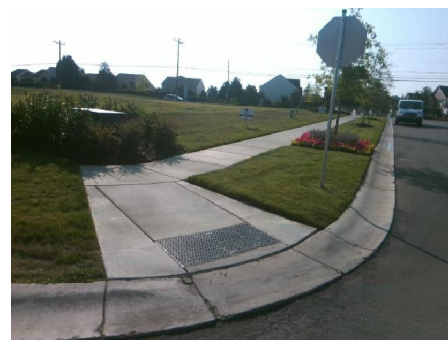
**NO LT SW**

**R304.5.1, R304.5.3**

| Compliance | Description | Data | Compliance | Description | Data |
|---|---|---|---|---|---|
| No | Ramp Width (in) | 47.5 | No | BlendTrans XSlope (%) | 2.4 |

**Remove & Replace Curb Ramp With Two New Directional Ramps or Equivalent.**
