Access Compliance Report Public Rights-of-Way (Curb Ramps)

Intersection ID: 42455 Main Street: SUNNINGHILL PARK RD **Cross Street: ROYAL CASTLE CT** Location: SW ADA ID: 7B8EF915CFE7 Ramp Type: PerpDiag Initial Pass/Fail: Fail **Overall Compliance: No Severity Score:** 8.75

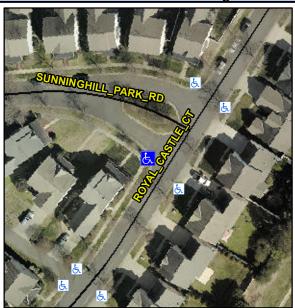
Not Found, R304.5.1

| Field Measurements/Component Compliance | | | | | |
|---|---|---|---|---|---|
| No | Ramp Width (in) | 44.0 | Yes | Ramp XSlope (%) | 0.2 |

Possible Solutions: **Remove & Replace Curb Ramp With** Two New Directional Ramps or Equivalent. Surveyor Notes:
