Access Compliance Report

Public Rights-of-Way

(Curb Ramps)

Intersection ID: 11625	Main Street: E_11TH_ST	Cross Street: N_COLLEGE_ST	Location: N
ADA ID: 7B95ED8AF6D0	Ramp Type: BlendTrans1	Initial Pass/Fail: Fail	Overall Compliance: No
Severity Score: 10			
Codes/Mitigation Info/Possible Solution		Field Measurements/Component Compliance

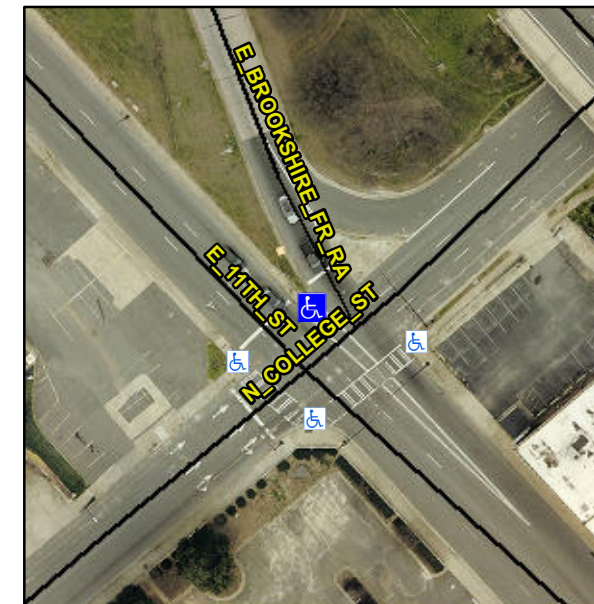
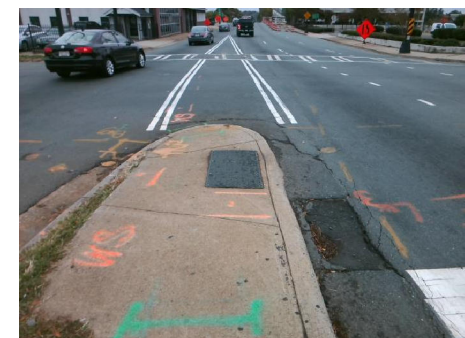
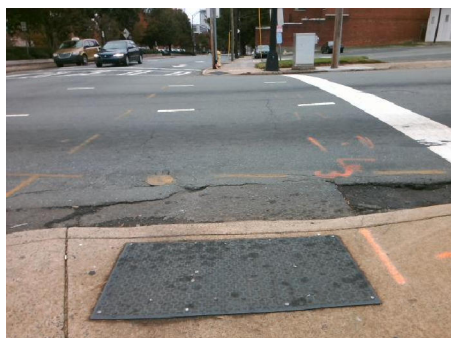
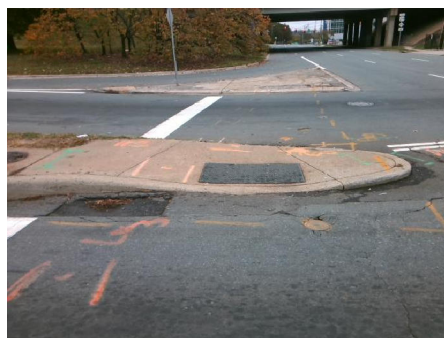
Not Found, R304.5.1, R304.5.3

Compliance	Description	Data	Compliance	Description	Data
N/A	Ramp Length (in)	32.0	Yes	BlendTrans Slope (%)	1.9
No	Ramp Width (in)	47.5	No	BlendTrans XSlope (%)	2.8
N/A	Flare Type LT	N/A	N/A	Flare Type RT	N/A
N/A	Flare Slope LT (%)	N/A	N/A	Flare Slope RT (%)	N/A
N/A	Flare Traversable LT?	N/A	N/A	Flare Traversable RT?	N/A
N/A	Landing Length (in)	N/A	N/A	DWS Provided?	N/A
N/A	Landing Width (in)	N/A	N/A	DWS Contrast?	N/A
N/A	Landing Slope (%)	N/A	N/A	DWS Length (in)	N/A
N/A	Landing X Slope (%)	N/A	N/A	DWS Full Width?	N/A
N/A	Landing Curb? (Y/N)	N/A	N/A	DWS Offset (in)	N/A
N/A	Shared Landing?	N/A			
N/A	Gutter Ponding?	N/A	N/A	Gutter Slope (%)	N/A
N/A	Gutter Lip Ht (in)	N/A	N/A	Gutter X Slope (%)	N/A
N/A	Painted X Walk1?	No	N/A	Painted X Walk2?	N/A
	X Walk 1 Direction	To SW		X Walk 2 Direction	N/A
	X Walk 1 Width (in)	N/A		X Walk 2 Width (in)	N/A
	X Walk 1 Slope (%)	3.2		X Walk 2 Slope (%)	N/A
	X Walk 1 X Slope (%)	1.6		X Walk 2 X Slope (%)	N/A

N/A	Ramp inside XWalk1?	N/A	N/A	Ramp inside XWalk2?	N/A
	Road Slope (%)	1.6		Clear Space?	N/A
	Road X Slope (%)	3.2	N/A	Clear Space to XWalk (in)	N/A
N/A	Any Obstructions?	N/A	N/A	Storm Grate/Utility Hazard?	N/A
	Obstruction Type			Storm Grate/Utility Type	
		N/A			N/A
			Yes	Surface Condition? (G/P)	Good
			No	Curb Slope (%)	14.3

Remove & Replace Curb Ramp With Two New Directional Ramps or Equivalent.
