Access Compliance Report

Public Rights-of-Way

(Curb Ramps)

Intersection ID: 29188	Main Street: JADE_GLEN_DR	Cross Street: SOUTHERN_SUGAR_DR	Location: SW
ADA ID: 7B9646DC1F7B	Ramp Type: PerpDiag	Initial Pass/Fail: Fail	Overall Compliance: No
		Severity Score: 10

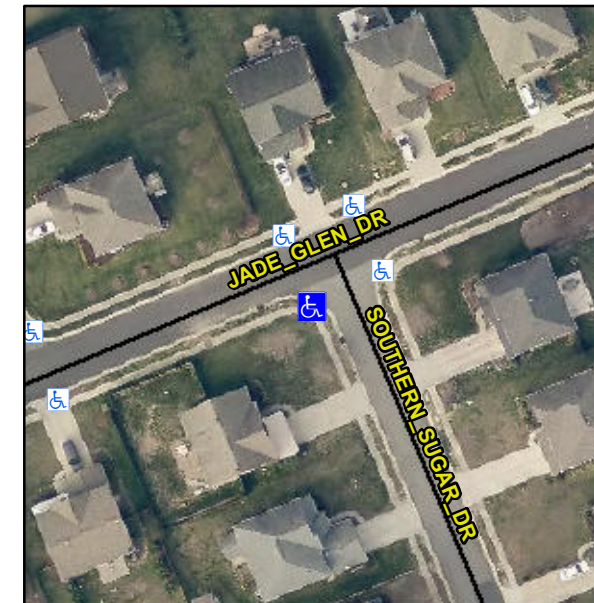
Not Found, R304.5.1, R304.5.3

Compliance	Description	Data	Compliance	Description	Data
N/A	Ramp Length (in)	46.0	Yes	Ramp Slope (%)	7.0
No	Ramp Width (in)	47.0	No	Ramp XSlope (%)	3.7
N/A	Flare Type LT	N/A	N/A	Flare Type RT	N/A
N/A	Flare Slope LT (%)	N/A	N/A	Flare Slope RT (%)	N/A
N/A	Flare Traversable LT?	N/A	N/A	Flare Traversable RT?	N/A
N/A	Landing Length (in)	N/A	N/A	DWS Provided?	N/A
N/A	Landing Width (in)	N/A	N/A	DWS Contrast?	N/A
N/A	Landing Slope (%)	N/A	N/A	DWS Length (in)	N/A
N/A	Landing X Slope (%)	N/A	N/A	DWS Full Width?	N/A
N/A	Landing Curb? (Y/N)	N/A	N/A	DWS Offset (in)	N/A
N/A	Shared Landing?	N/A			
N/A	Gutter Ponding?	N/A	N/A	Gutter Slope (%)	N/A
N/A	Gutter Lip Ht (in)	N/A	N/A	Gutter X Slope (%)	N/A
N/A	Painted X Walk1?	No	N/A	Painted X Walk2?	No
	X Walk 1 Direction	To N		X Walk 2 Direction	To E
N/A	X Walk 1 Width (in)	N/A	N/A	X Walk 2 Width (in)	N/A
	X Walk 1 Slope (%)	0.7		X Walk 2 Slope (%)	4.6
	X Walk 1 X Slope (%)	3.4		X Walk 2 X Slope (%)	0.1

N/A	Ramp inside XWalk1?	N/A	N/A	Ramp inside XWalk2?	N/A
	Road Slope (%)	3.1	N/A	Clear Space?	N/A
	Road X Slope (%)	1.4	N/A	Clear Space to XWalk (in)	N/A
N/A	Any Obstructions?	N/A	N/A	Storm Grate/Utility Hazard?	N/A
	Obstruction Type			Storm Grate/Utility Type	
		N/A			N/A
			Yes	Surface Condition? (G/P)	Good

Remove & Replace Curb Ramp With Two New Directional Ramps or Equivalent.
