# Access Compliance Report

## Public Rights-of-Way

### (Curb Ramps)

| Intersection ID: 13227 | Main Street: SUNNYSIDE_AV | Cross Street: LAMAR_AV | Location: SW |

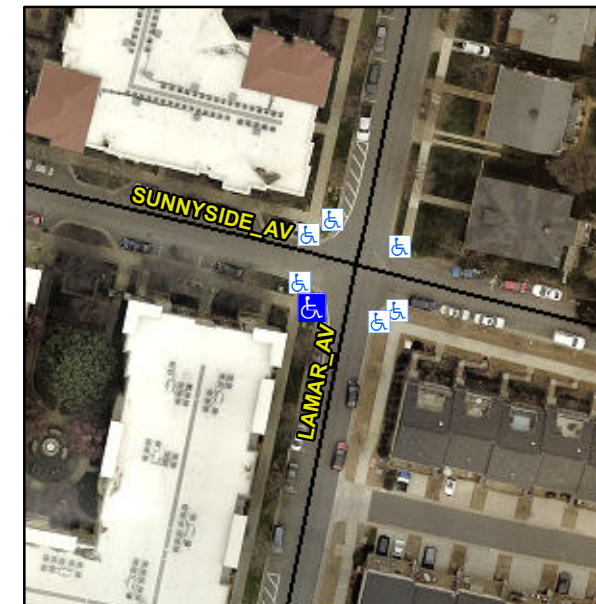
**R304.2.2-Perp, R304.3.2-Para,  
R304.5.3, R305.1.4, R305.2, R302.7.2**

| Compliance | Description | Data | Compliance | Description | Data |
|---|---|---|---|---|---|
| Yes | Ramp Width (in) | 73.0 | No | Grade Break Slope (%) | 5.6 |
| No | Landing Slope (%) | 2.4 | Yes | DWS Length (in) | 24.0 |
| Yes | Landing X Slope (%) | 0.7 | No | DWS Full Width? | No |
| N/A | Shared Landing? | Yes | No | DWS Offset RT (in) | 5.5 |
| No | Gutter Lip Ht (in) | 0.5 | Yes | Gutter X Slope (%) | 1.4 |

**Remove & Replace Entire Ramp.  
Grind Gutter Lip.**

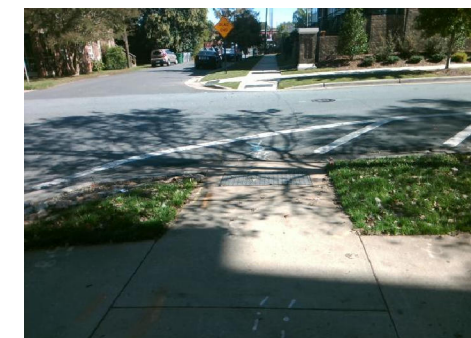
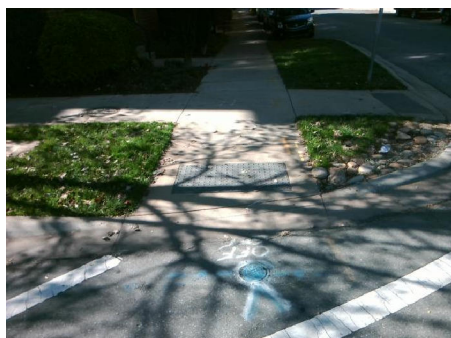
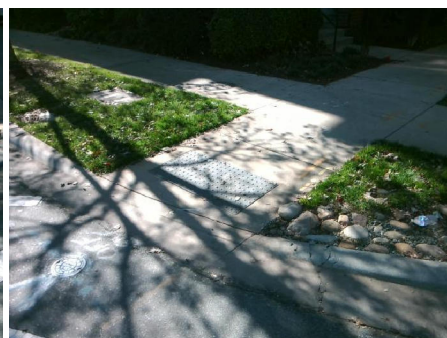
| ADA ID: 7B9E5829FA2B | Ramp Type: Directional1 | Initial Pass/Fail: Pass | Overall Compliance: No |
| | | | Severity Score: 10.25 |
