# Access Compliance Report

## Public Rights-of-Way (Curb Ramps)

Intersection ID: 48320	Main Street: NORTHLAKE_MALL_DR	Cross Street: NORTHLAKE_COMMONS_BV	Location: SW
ADA ID: 7BA2859B4801	Ramp Type: Perp	Initial Pass/Fail: Fail	Overall Compliance: No
Severity Score: 18.75			
Codes/Mitigation Info/Possible Solution		Field Measurements/Component Compliance

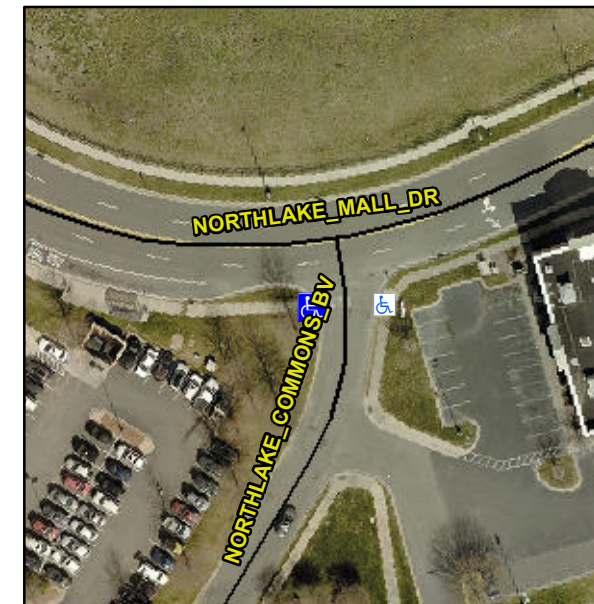
**Not Found, R304.5.1, R304.5.3**

Compliance	Description	Data	Compliance	Description	Data
N/A	Ramp Length (in)	77.0	Yes	Ramp Slope (%)	6.0
No	Ramp Width (in)	35.0	No	Ramp XSlope (%)	3.2
N/A	Flare Type LT	N/A	N/A	Flare Type RT	N/A
N/A	Flare Slope LT (%)	N/A	N/A	Flare Slope RT (%)	N/A
N/A	Flare Traversable LT?	N/A	N/A	Flare Traversable RT?	N/A
N/A	Landing Length (in)	N/A	N/A	DWS Provided?	N/A
N/A	Landing Width (in)	N/A	N/A	DWS Contrast?	N/A
N/A	Landing Slope (%)	N/A	N/A	DWS Length (in)	N/A
N/A	Landing X Slope (%)	N/A	N/A	DWS Full Width?	N/A
N/A	Landing Curb? (Y/N)	N/A	N/A	DWS Offset (in)	N/A
N/A	Shared Landing?	N/A			
N/A	Gutter Ponding?	N/A	N/A	Gutter Slope (%)	N/A
N/A	Gutter Lip Ht (in)	N/A	N/A	Gutter X Slope (%)	N/A
N/A	Painted X Walk1?	Yes	N/A	Painted X Walk2?	N/A
	X Walk 1 Direction	To E		X Walk 2 Direction	N/A
N/A	X Walk 1 Width (in)	60.0	N/A	X Walk 2 Width (in)	N/A
	X Walk 1 Slope (%)	0.7		X Walk 2 Slope (%)	N/A
	X Walk 1 X Slope (%)	2.8		X Walk 2 X Slope (%)	N/A

N/A	Ramp inside XWalk1?	Yes	N/A	Ramp inside XWalk2?	N/A
	Road Slope (%)	N/A	N/A	Clear Space?	N/A
	Road X Slope (%)	N/A	N/A	Clear Space to XWalk (in)	N/A
N/A	Any Obstructions?	N/A	N/A	Storm Grate/Utility Hazard?	N/A
	Obstruction Type			Storm Grate/Utility Type	
		N/A			N/A
			Yes	Surface Condition? (G/P)	Good

**Remove & Replace Entire Ramp.**

Total Cost: \$ 1850.00
