Access Compliance Report

Public Rights-of-Way

(Curb Ramps)

Intersection ID: 15013	Main Street: E_WORTHINGTON_AV	Cross Street: EWING_AV	Location: N
ADA ID: 7BB773E92459	Ramp Type: Perp	Initial Pass/Fail: Fail	Overall Compliance: No
			Severity Score: 33.75

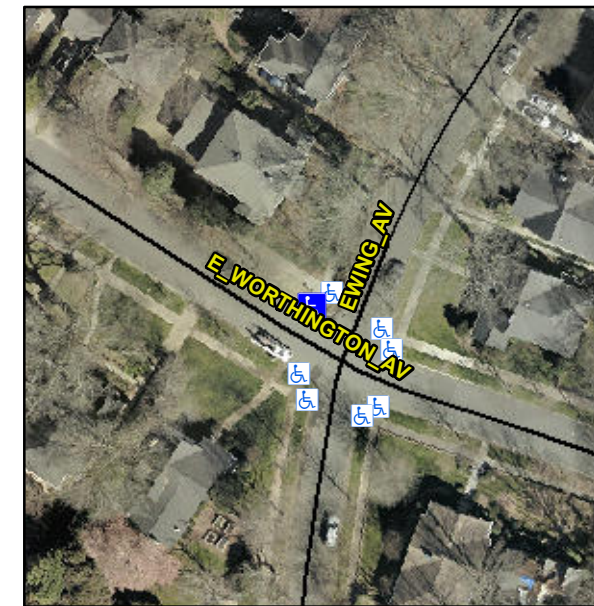
Not Found, R304.5.1, R304.2.2, R304.5.3

Compliance	Description	Data	Compliance	Description	Data
N/A	Ramp Length (in)	105.0	No	Ramp Slope (%)	8.6
No	Ramp Width (in)	36.0	No	Ramp XSlope (%)	6.1
N/A	Flare Type LT	N/A	N/A	Flare Type RT	N/A
N/A	Flare Slope LT (%)	N/A	N/A	Flare Slope RT (%)	N/A
N/A	Flare Traversable LT?	N/A	N/A	Flare Traversable RT?	N/A
N/A	Landing Length (in)	N/A	N/A	DWS Provided?	N/A
N/A	Landing Width (in)	N/A	N/A	DWS Contrast?	N/A
N/A	Landing Slope (%)	N/A	N/A	DWS Length (in)	N/A
N/A	Landing X Slope (%)	N/A	N/A	DWS Full Width?	N/A
N/A	Landing Curb? (Y/N)	N/A	N/A	DWS Offset (in)	N/A
N/A	Shared Landing?	N/A			
N/A	Gutter Ponding?	Yes	N/A	Gutter Slope (%)	N/A
N/A	Gutter Lip Ht (in)	N/A	N/A	Gutter X Slope (%)	N/A
N/A	Painted X Walk1?	No	N/A	Painted X Walk2?	N/A
	X Walk 1 Direction	To SW		X Walk 2 Direction	N/A
N/A	X Walk 1 Width (in)	N/A	N/A	X Walk 2 Width (in)	N/A
	X Walk 1 Slope (%)	4.3		X Walk 2 Slope (%)	N/A
	X Walk 1 X Slope (%)	0.9		X Walk 2 X Slope (%)	N/A

N/A	Ramp inside XWalk1?	N/A	N/A	Ramp inside XWalk2?	N/A
	Road Slope (%)	N/A	N/A	Clear Space?	N/A
	Road X Slope (%)	N/A	N/A	Clear Space to XWalk (in)	N/A
N/A	Any Obstructions?	N/A	N/A	Storm Grate/Utility Hazard?	N/A
	Obstruction Type			Storm Grate/Utility Type	
		N/A			N/A
			Yes	Surface Condition? (G/P)	Good

Remove & Replace Entire Ramp.
