Access Compliance Report

Public Rights-of-Way

(Curb Ramps)

Intersection ID: 19165	Main Street: BEARMORE_DR	Cross Street: ROCKY_FALLS_RD	Location:	NE
ADA ID: 7BBDC3C38919	Ramp Type: BlendTrans1	Initial Pass/Fail: Fail	Overall Compliance: No	Severity Score: 10
Codes/Mitigation Info/Possible Solution		Field Measurements/Component Compliance

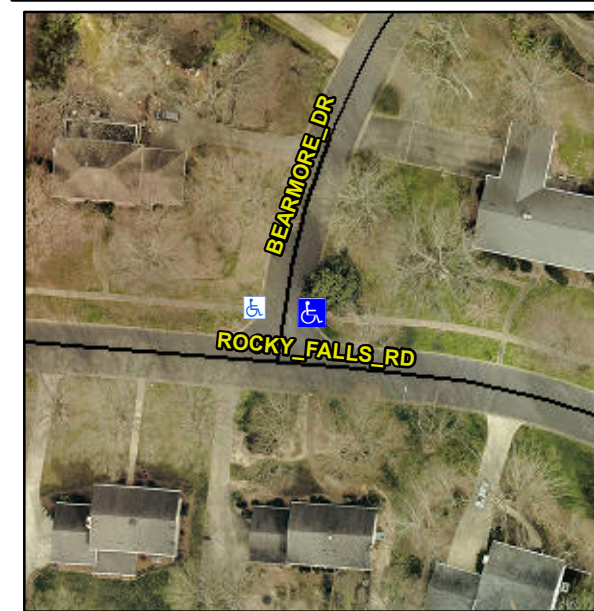
Not Found, R304.5.1, R304.5.3

Compliance	Description	Data	Compliance	Description	Data
N/A	Ramp Length (in)	76.0	Yes	BlendTrans Slope (%)	3.7
No	Ramp Width (in)	43.0	No	BlendTrans XSlope (%)	3.5
N/A	Flare Type LT	N/A	N/A	Flare Type RT	N/A
N/A	Flare Slope LT (%)	N/A	N/A	Flare Slope RT (%)	N/A
N/A	Flare Traversable LT?	N/A	N/A	Flare Traversable RT?	N/A
N/A	Landing Length (in)	N/A	N/A	DWS Provided?	N/A
N/A	Landing Width (in)	N/A	N/A	DWS Contrast?	N/A
N/A	Landing Slope (%)	N/A	N/A	DWS Length (in)	N/A
N/A	Landing X Slope (%)	N/A	N/A	DWS Full Width?	N/A
N/A	Landing Curb? (Y/N)	N/A	N/A	DWS Offset (in)	N/A
N/A	Shared Landing?	N/A			
N/A	Gutter Ponding?	N/A	N/A	Gutter Slope (%)	N/A
N/A	Gutter Lip Ht (in)	N/A	N/A	Gutter X Slope (%)	N/A
N/A	Painted X Walk1?	No	N/A	Painted X Walk2?	N/A
	X Walk 1 Direction	To W		X Walk 2 Direction	N/A
	X Walk 1 Width (in)	N/A		X Walk 2 Width (in)	N/A
	X Walk 1 Slope (%)	7.6		X Walk 2 Slope (%)	N/A
	X Walk 1 X Slope (%)	0.8		X Walk 2 X Slope (%)	N/A

N/A	Ramp inside XWalk1?	N/A	N/A	Ramp inside XWalk2?	N/A
	Road Slope (%)	0.8		Clear Space?	N/A
	Road X Slope (%)	7.6	N/A	Clear Space to XWalk (in)	N/A
N/A	Any Obstructions?	N/A	N/A	Storm Grate/Utility Hazard?	N/A
	Obstruction Type			Storm Grate/Utility Type	
		N/A			N/A
			Yes	Surface Condition? (G/P)	Good
			No	Curb Slope (%)	9.0

Remove & Replace Curb Ramp With Two New Directional Ramps or Equivalent.
