Access Compliance Report

Public Rights-of-Way

(Curb Ramps)

Intersection ID: 14648	Main Street: EAST_BV	Cross Street: LENNOX_AV	Location: W
ADA ID: 7BC2EAE657ED	Ramp Type: Directional1	Initial Pass/Fail: Pass	Overall Compliance: No
		Severity Score: 0

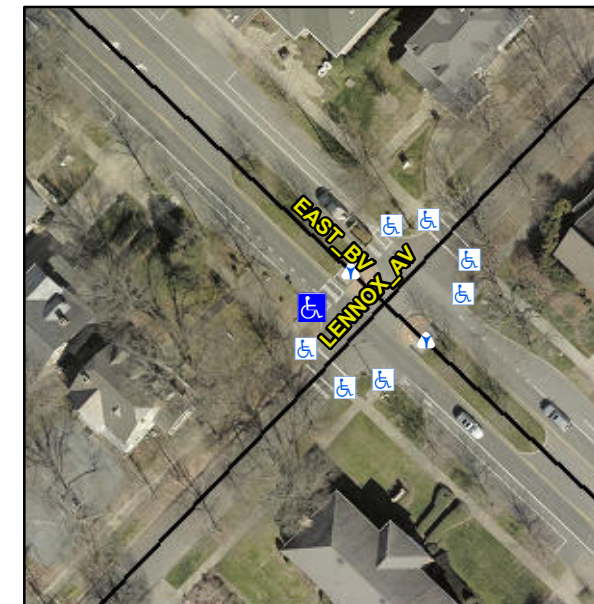
Compliance	Description	Data	Compliance	Description	Data
N/A	Ramp Length (in)	76.0	Yes	Grade Break?	Yes
Yes	Ramp Width (in)	72.0	Yes	Grade Break Slope (%)	2.6
Yes	Ramp Slope (%)	4.8	Yes	Grade Break XSlope (%)	1.6
Yes	Ramp XSlope (%)	1.9			
Yes	Flare Type LT	N/A	Yes	Flare Type RT	N/A
N/A	Flare Slope LT (%)	N/A	N/A	Flare Slope RT (%)	N/A
N/A	Flare Traversable LT?	No	N/A	Flare Traversable RT?	No
Yes	Landing Length (in)	54.0	Yes	DWS Provided?	Yes
Yes	Landing Width (in)	72.0	Yes	DWS Contrast?	Yes
No	Landing Slope (%)	2.4	Yes	DWS Length (in)	24.0
Yes	Landing X Slope (%)	0.3	Yes	DWS Full Width?	Yes
N/A	Landing Curb? (Y/N)	No	Yes	DWS Offset LT (in)	1.0
N/A	Shared Landing?	No	Yes	DWS Offset RT (in)	18.0
Yes	Gutter Ponding?	No	Yes	Gutter Slope (%)	1.6
Yes	Gutter Lip Ht (in)	0.0	Yes	Gutter X Slope (%)	1.4
N/A	Painted X Walk1?	Yes		Road Slope (%)	4.8
	X Walk 1 Direction	To NE		Road X Slope (%)	1.0
	X Walk 1 Width (in)	110.0		Clear Space?	Yes

X Walk 1 Slope (%)	4.8	N/A	Clear Space to XWalk (in)	N/A
	X Walk 1 X Slope (%)	1.0	Yes	Storm Grate/Utility Hazard?	No
Yes	Ramp inside XWalk1?	Yes		Storm Grate/Utility Type	
Yes	Any Obstructions?	No			N/A
	Obstruction Type		Yes	Surface Condition? (G/P)	Good
			N/A	Curb Slope (%)	2.4

Possible Solutions:

Remove & Replace Landing.

R304.2.2-Perp, R304.3.2-Para
