Access Compliance Report

Public Rights-of-Way

(Curb Ramps)

Intersection ID: 14215	Main Street: MYRTLE_AV	Cross Street: ROMANY_RD	Location: NE
ADA ID: 7BC9E33DF219	Ramp Type: Perp	Initial Pass/Fail: Fail	Overall Compliance: No
		Severity Score: 25

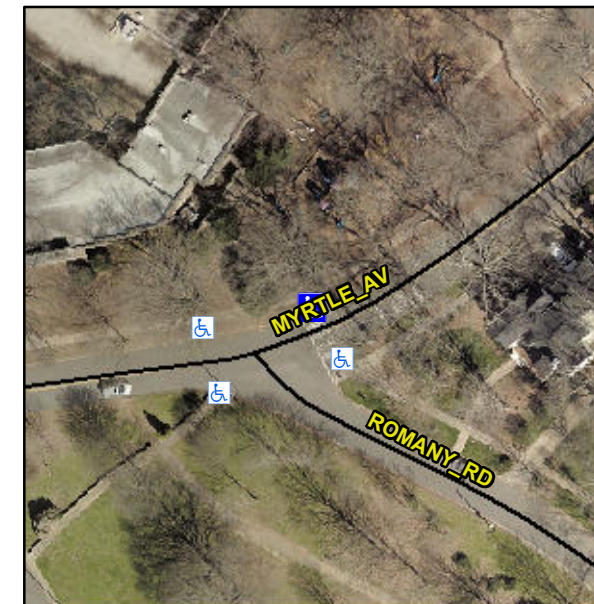
Compliance	Description	Data	Compliance	Description	Data
N/A	Ramp Length (in)	88.0	No	Ramp Slope (%)	9.1
Yes	Ramp Width (in)	48.0	No	Ramp XSlope (%)	6.7
N/A	Flare Type LT	N/A	N/A	Flare Type RT	N/A
N/A	Flare Slope LT (%)	N/A	N/A	Flare Slope RT (%)	N/A
N/A	Flare Traversable LT?	N/A	N/A	Flare Traversable RT?	N/A
N/A	Landing Length (in)	N/A	N/A	DWS Provided?	N/A
N/A	Landing Width (in)	N/A	N/A	DWS Contrast?	N/A
N/A	Landing Slope (%)	N/A	N/A	DWS Length (in)	N/A
N/A	Landing X Slope (%)	N/A	N/A	DWS Full Width?	N/A
N/A	Landing Curb? (Y/N)	N/A	N/A	DWS Offset (in)	N/A
N/A	Shared Landing?	N/A			
N/A	Gutter Ponding?	N/A	N/A	Gutter Slope (%)	N/A
N/A	Gutter Lip Ht (in)	N/A	N/A	Gutter X Slope (%)	N/A
N/A	Painted X Walk1?	Yes	N/A	Painted X Walk2?	N/A
	X Walk 1 Direction	To S		X Walk 2 Direction	N/A
N/A	X Walk 1 Width (in)	108.0	N/A	X Walk 2 Width (in)	N/A
	X Walk 1 Slope (%)	6.5		X Walk 2 Slope (%)	N/A
	X Walk 1 X Slope (%)	2.8		X Walk 2 X Slope (%)	N/A

N/A	Ramp inside XWalk1?	Yes	N/A	Ramp inside XWalk2?	N/A
	Road Slope (%)	N/A	N/A	Clear Space?	N/A
	Road X Slope (%)	N/A	N/A	Clear Space to XWalk (in)	N/A
N/A	Any Obstructions?	N/A	N/A	Storm Grate/Utility Hazard?	N/A
	Obstruction Type			Storm Grate/Utility Type	
		N/A			N/A
		Yes		Surface Condition? (G/P)	Good

Remove & Replace Entire Ramp.

R304.2.2, R304.5.3
