Access Compliance Report

Public Rights-of-Way

(Curb Ramps)

Intersection ID: 44298	Main Street: PEACH_PLACE_LN	Cross Street: CRANDON_DR	Location: NE
ADA ID: 7BCF3C72B5CA	Ramp Type: PerpDiag	Initial Pass/Fail: Pass	Overall Compliance: No
Severity Score: 0.25			
Codes/Mitigation Info/Possible Solution		Field Measurements/Component Compliance

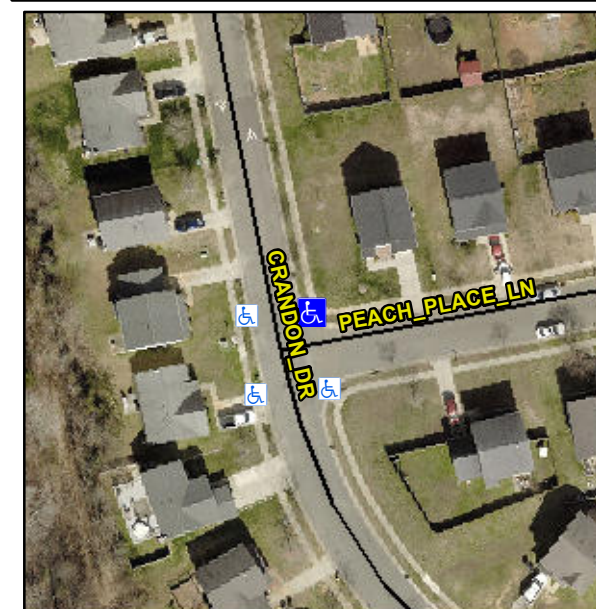
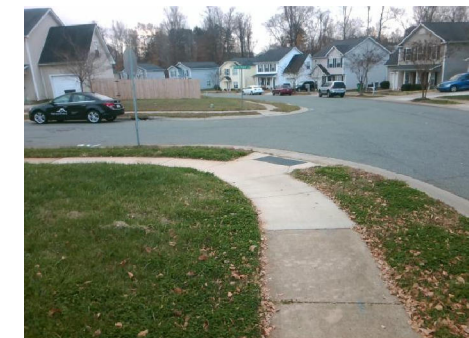
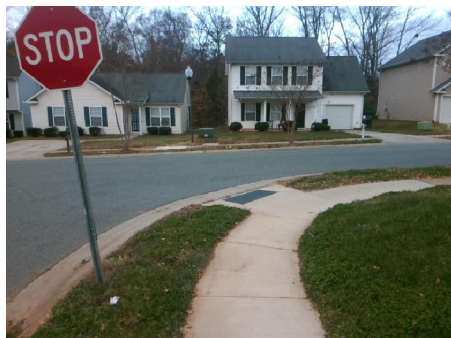
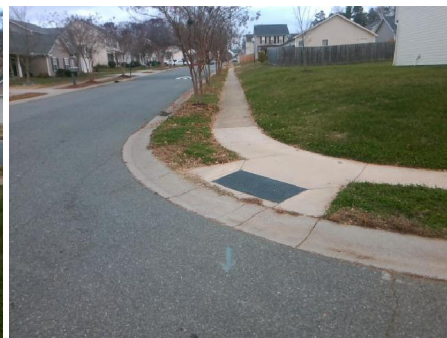
Compliance	Description	Data	Compliance	Description	Data
N/A	Ramp Length (in)	30.0	Yes	Ramp Slope (%)	6.2
Yes	Ramp Width (in)	48.0	No	Ramp XSlope (%)	4.1
N/A	Flare Type LT	Sloped	N/A	Flare Type RT	N/A
N/A	Flare Slope LT (%)	4.4	N/A	Flare Slope RT (%)	1.4
N/A	Flare Traversable LT?	No	N/A	Flare Traversable RT?	No
Yes	Landing Length (in)	62.0	Yes	DWS Provided?	Yes
Yes	Landing Width (in)	48.0	Yes	DWS Contrast?	Yes
Yes	Landing Slope (%)	1.9	Yes	DWS Length (in)	24.0
No	Landing X Slope (%)	3.0	Yes	DWS Full Width?	Yes
N/A	Landing Curb? (Y/N)	No	No	DWS Offset (in)	6.0
N/A	Shared Landing?	N/A			
Yes	Gutter Ponding?	No	Yes	Gutter Slope (%)	1.1
Yes	Gutter Lip Ht (in)	0.0	No	Gutter X Slope (%)	2.1
N/A	Painted X Walk1?	No	N/A	Painted X Walk2?	No
	X Walk 1 Direction	To W		X Walk 2 Direction	To S
N/A	X Walk 1 Width (in)	N/A	N/A	X Walk 2 Width (in)	N/A
	X Walk 1 Slope (%)	0.7		X Walk 2 Slope (%)	4.5
	X Walk 1 X Slope (%)	4.0		X Walk 2 X Slope (%)	0.4

N/A	Ramp inside XWalk1?	N/A	N/A	Ramp inside XWalk2?	N/A
	Road Slope (%)	2.3	N/A	Clear Space?	Yes
	Road X Slope (%)	1.9	N/A	Clear Space to XWalk (in)	N/A
Yes	Any Obstructions?	No	Yes	Storm Grate/Utility Hazard?	No
	Obstruction Type			Storm Grate/Utility Type	
		N/A			N/A
		Yes		Surface Condition? (G/P)	Good

Remove & Replace Curb Ramp With Two New Directional Ramps or Equivalent. Remove & Replace Gutter.

R304.5.3, R305.2
