Access Compliance Report

Public Rights-of-Way

(Curb Ramps)

Intersection ID: 28066	Main Street: LANDEN_DR	Cross Street: OLD_SOUTH_CT	Location: SE
ADA ID: 7BD647962D34	Ramp Type: PerpDiag	Initial Pass/Fail: Fail	Overall Compliance: No
			Severity Score: 58.75

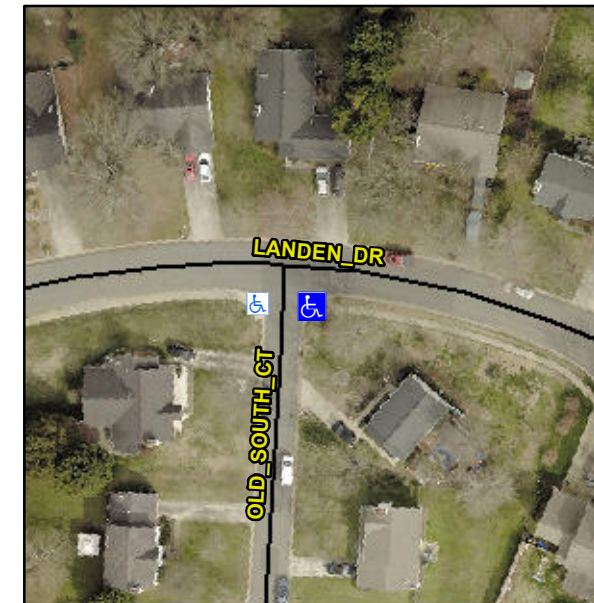
Not Found, R304.5.1, R304.2.2, R304.5.3

Compliance	Description	Data	Compliance	Description	Data
N/A	Ramp Length (in)	92.0	No	Ramp Slope (%)	12.3
No	Ramp Width (in)	43.0	No	Ramp XSlope (%)	7.9
N/A	Flare Type LT	N/A	N/A	Flare Type RT	N/A
N/A	Flare Slope LT (%)	N/A	N/A	Flare Slope RT (%)	N/A
N/A	Flare Traversable LT?	N/A	N/A	Flare Traversable RT?	N/A
N/A	Landing Length (in)	N/A	N/A	DWS Provided?	N/A
N/A	Landing Width (in)	N/A	N/A	DWS Contrast?	N/A
N/A	Landing Slope (%)	N/A	N/A	DWS Length (in)	N/A
N/A	Landing X Slope (%)	N/A	N/A	DWS Full Width?	N/A
N/A	Landing Curb? (Y/N)	N/A	N/A	DWS Offset (in)	N/A
N/A	Shared Landing?	N/A			
N/A	Gutter Ponding?	N/A	N/A	Gutter Slope (%)	N/A
N/A	Gutter Lip Ht (in)	1.0	N/A	Gutter X Slope (%)	N/A
N/A	Painted X Walk1?	No	N/A	Painted X Walk2?	No
	X Walk 1 Direction	To NE		X Walk 2 Direction	To NW
N/A	X Walk 1 Width (in)	N/A	N/A	X Walk 2 Width (in)	N/A
	X Walk 1 Slope (%)	2.9		X Walk 2 Slope (%)	3.3
	X Walk 1 X Slope (%)	2.1		X Walk 2 X Slope (%)	2.4

Remove & Replace Curb Ramp With Two New Directional Ramps or Equivalent.

Total Cost: \$ 3200.00
