Access Compliance Report

Public Rights-of-Way

(Curb Ramps)

Intersection ID: 10019902	Main Street: ARCO_CORPORATE_DR	Cross Street: N/A	Location: NW
ADA ID: 7BDDD2F3A7F9	Ramp Type: PerpDiag	Initial Pass/Fail: Fail	Overall Compliance: No
Severity Score: 22.5			
Codes/Mitigation Info/Possible Solution		Field Measurements/Component Compliance

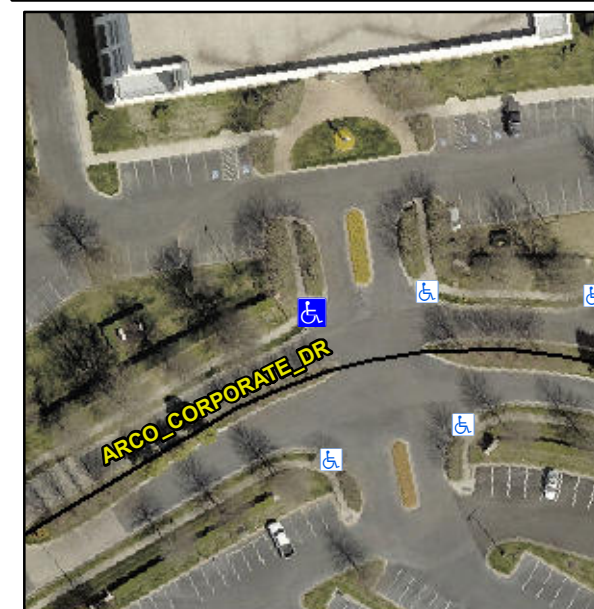
R304.5.1, R304.2.2, R304.5.3

Compliance	Description	Data	Compliance	Description	Data
N/A	Ramp Length (in)	50.0	No	Ramp Slope (%)	11.6
No	Ramp Width (in)	41.0	No	Ramp XSlope (%)	3.2
N/A	Flare Type LT	N/A	N/A	Flare Type RT	N/A
N/A	Flare Slope LT (%)	N/A	N/A	Flare Slope RT (%)	N/A
N/A	Flare Traversable LT?	N/A	N/A	Flare Traversable RT?	N/A
N/A	Landing Length (in)	N/A	N/A	DWS Provided?	N/A
N/A	Landing Width (in)	N/A	N/A	DWS Contrast?	N/A
N/A	Landing Slope (%)	N/A	N/A	DWS Length (in)	N/A
N/A	Landing X Slope (%)	N/A	N/A	DWS Full Width?	N/A
N/A	Landing Curb? (Y/N)	N/A	N/A	DWS Offset (in)	N/A
N/A	Shared Landing?	N/A			
N/A	Gutter Ponding?	N/A	N/A	Gutter Slope (%)	N/A
N/A	Gutter Lip Ht (in)	N/A	N/A	Gutter X Slope (%)	N/A
N/A	Painted X Walk1?	No	N/A	Painted X Walk2?	No
	X Walk 1 Direction	To S		X Walk 2 Direction	To E
N/A	X Walk 1 Width (in)	N/A	N/A	X Walk 2 Width (in)	N/A
	X Walk 1 Slope (%)	2.4		X Walk 2 Slope (%)	3.6
	X Walk 1 X Slope (%)	2.3		X Walk 2 X Slope (%)	3.3

N/A	Ramp inside XWalk1?	N/A	N/A	Ramp inside XWalk2?	N/A
	Road Slope (%)	1.2	N/A	Clear Space?	N/A
	Road X Slope (%)	6.1	N/A	Clear Space to XWalk (in)	N/A
N/A	Any Obstructions?	N/A	N/A	Storm Grate/Utility Hazard?	N/A
	Obstruction Type			Storm Grate/Utility Type	
		N/A			N/A
			Yes	Surface Condition? (G/P)	Good

Remove & Replace Curb Ramp With Two New Directional Ramps or Equivalent.
