Access Compliance Report

Public Rights-of-Way

(Curb Ramps)

Intersection ID: 13538	Main Street: SOUTHWOOD_AV	Cross Street: W_PARK_AV	Location:	N
ADA ID: 7BDE6B168745	Ramp Type: BlendTrans1	Initial Pass/Fail: Fail	Overall Compliance: No	Severity Score: 1.25
Codes/Mitigation Info/Possible Solution		Field Measurements/Component Compliance

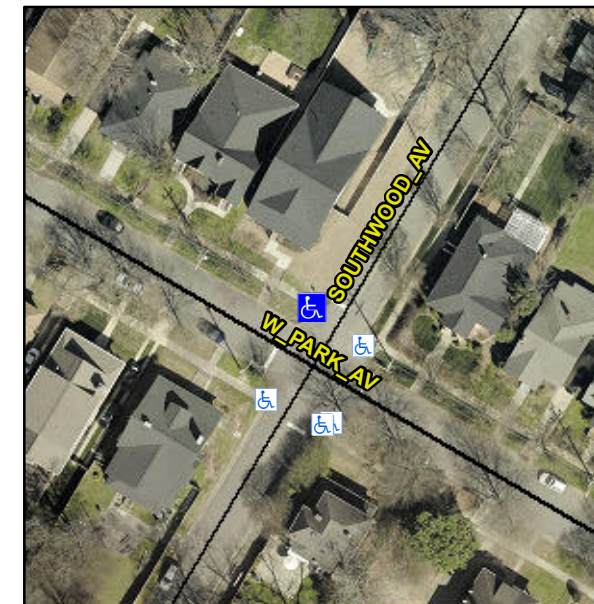
Not Found, R304.5.3

Compliance	Description	Data	Compliance	Description	Data
N/A	Ramp Length (in)	64.0	Yes	BlendTrans Slope (%)	3.5
Yes	Ramp Width (in)	60.0	No	BlendTrans XSlope (%)	4.4
N/A	Flare Type LT	N/A	N/A	Flare Type RT	N/A
N/A	Flare Slope LT (%)	N/A	N/A	Flare Slope RT (%)	N/A
N/A	Flare Traversable LT?	N/A	N/A	Flare Traversable RT?	N/A
N/A	Landing Length (in)	N/A	N/A	DWS Provided?	N/A
N/A	Landing Width (in)	N/A	N/A	DWS Contrast?	N/A
N/A	Landing Slope (%)	N/A	N/A	DWS Length (in)	N/A
N/A	Landing X Slope (%)	N/A	N/A	DWS Full Width?	N/A
N/A	Landing Curb? (Y/N)	N/A	N/A	DWS Offset (in)	N/A
N/A	Shared Landing?	N/A			
N/A	Gutter Ponding?	N/A	N/A	Gutter Slope (%)	N/A
N/A	Gutter Lip Ht (in)	N/A	N/A	Gutter X Slope (%)	N/A
N/A	Painted X Walk1?	No	N/A	Painted X Walk2?	No
	X Walk 1 Direction	To SW		X Walk 2 Direction	To SE
	X Walk 1 Width (in)	N/A		X Walk 2 Width (in)	N/A
	X Walk 1 Slope (%)	2.8		X Walk 2 Slope (%)	4.5
	X Walk 1 X Slope (%)	1.6		X Walk 2 X Slope (%)	5.9

N/A	Ramp inside XWalk1?	N/A	N/A	Ramp inside XWalk2?	N/A
	Road Slope (%)	4.0		Clear Space?	N/A
	Road X Slope (%)	3.6	N/A	Clear Space to XWalk (in)	N/A
N/A	Any Obstructions?	N/A	N/A	Storm Grate/Utility Hazard?	N/A
	Obstruction Type			Storm Grate/Utility Type	
		N/A			N/A
			Yes	Surface Condition? (G/P)	Good
			No	Curb Slope (%)	19.4

Possible Solutions:

Remove & Replace Curb Ramp With Two New Directional Ramps or Equivalent.

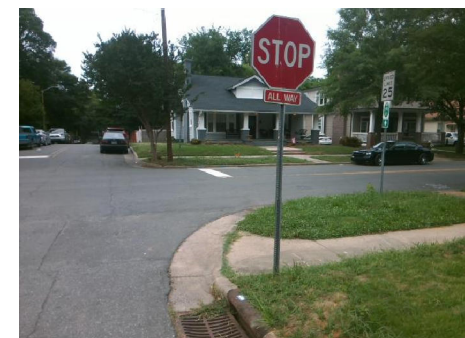
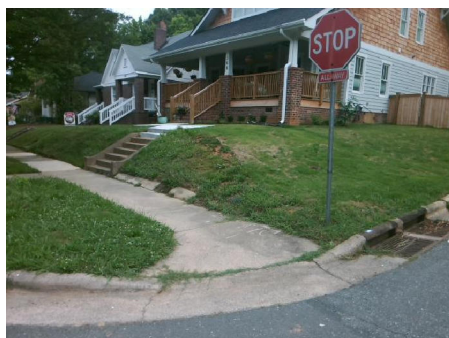
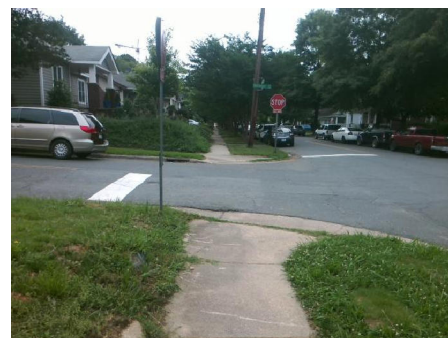
Street 1 Name W PARK AV
 Stop Condition-Street 1 StopSign
 Street 2 Name SOUTHWOOD AV
 Stop Condition-Street 2 StopSign
