# Access Compliance Report

## Public Rights-of-Way

### (Curb Ramps)

Intersection ID: 10029993	Main Street: LANCASTER_HY	Cross Street: N/A	Location: SE
ADA ID: 7BE340F5DA24	Ramp Type: Perp	Initial Pass/Fail: Fail	Overall Compliance: No
Severity Score: 25			
Codes/Mitigation Info/Possible Solution		Field Measurements/Component Compliance

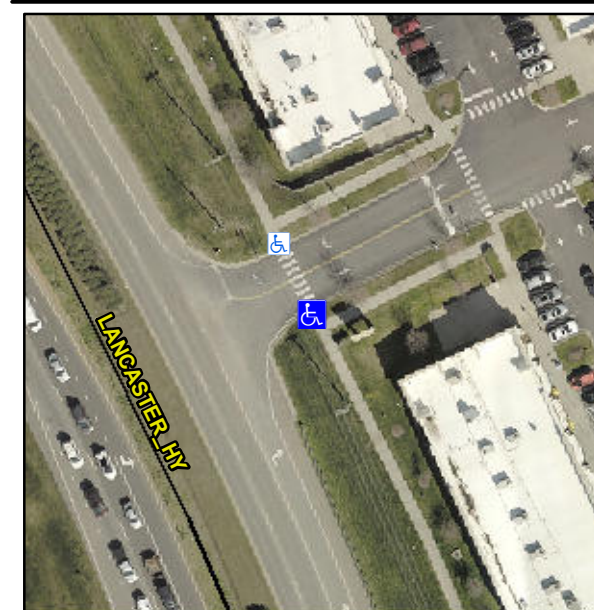
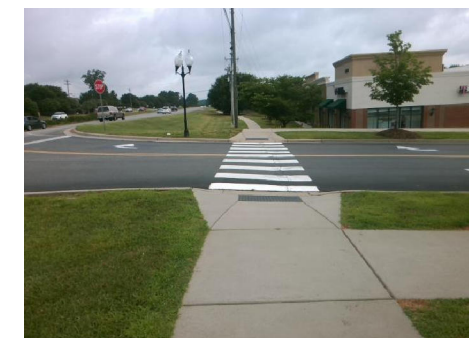
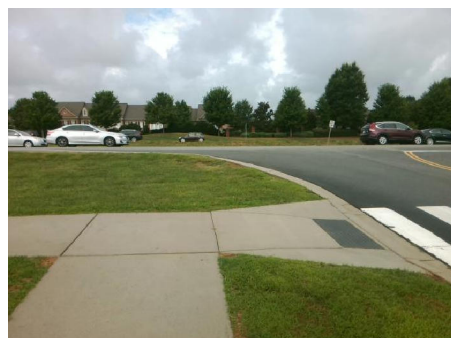
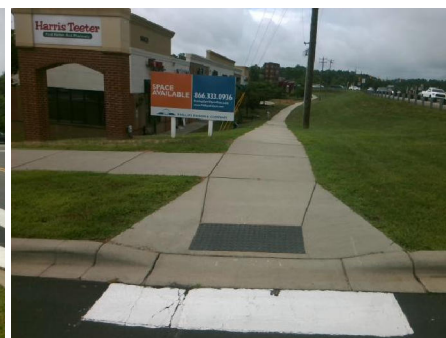
**Not Found, R304.2.2, R304.5.3**

Compliance	Description	Data	Compliance	Description	Data
N/A	Ramp Length (in)	95.0	No	Ramp Slope (%)	8.4
Yes	Ramp Width (in)	48.0	No	Ramp XSlope (%)	5.7
N/A	Flare Type LT	N/A	N/A	Flare Type RT	N/A
N/A	Flare Slope LT (%)	N/A	N/A	Flare Slope RT (%)	N/A
N/A	Flare Traversable LT?	N/A	N/A	Flare Traversable RT?	N/A
N/A	Landing Length (in)	N/A	N/A	DWS Provided?	N/A
N/A	Landing Width (in)	N/A	N/A	DWS Contrast?	N/A
N/A	Landing Slope (%)	N/A	N/A	DWS Length (in)	N/A
N/A	Landing X Slope (%)	N/A	N/A	DWS Full Width?	N/A
N/A	Landing Curb? (Y/N)	N/A	N/A	DWS Offset (in)	N/A
N/A	Shared Landing?	N/A			
N/A	Gutter Ponding?	N/A	N/A	Gutter Slope (%)	N/A
N/A	Gutter Lip Ht (in)	N/A	N/A	Gutter X Slope (%)	N/A
N/A	Painted X Walk1?	Yes	N/A	Painted X Walk2?	N/A
	X Walk 1 Direction	To N		X Walk 2 Direction	N/A
N/A	X Walk 1 Width (in)	96.0	N/A	X Walk 2 Width (in)	N/A
	X Walk 1 Slope (%)	0.2		X Walk 2 Slope (%)	N/A
	X Walk 1 X Slope (%)	11.0		X Walk 2 X Slope (%)	N/A

N/A	Ramp inside XWalk1?	Yes	N/A	Ramp inside XWalk2?	N/A
	Road Slope (%)	N/A	N/A	Clear Space?	N/A
	Road X Slope (%)	N/A	N/A	Clear Space to XWalk (in)	N/A
N/A	Any Obstructions?	N/A	N/A	Storm Grate/Utility Hazard?	N/A
	Obstruction Type			Storm Grate/Utility Type	
		N/A			N/A
		Yes		Surface Condition? (G/P)	Good

**Remove & Replace Entire Ramp.**
