Access Compliance Report

Public Rights-of-Way

(Curb Ramps)

Intersection ID: 12436	Main Street: EASTWAY_DR	Cross Street: SANDHURST_DR	Location: W
ADA ID: 7BF03CA5344D	Ramp Type: Perp	Initial Pass/Fail: Fail	Overall Compliance: No
Severity Score: 21.25			
Codes/Mitigation Info/Possible Solution		Field Measurements/Component Compliance

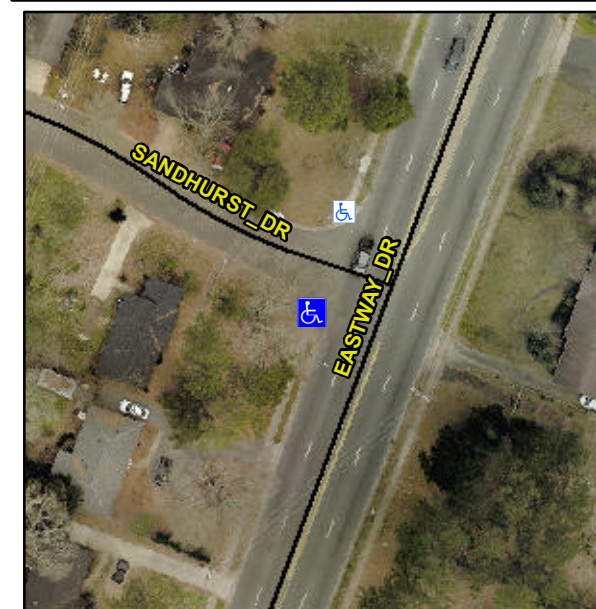
Not Found, R304.5.1, R304.5.3

Compliance	Description	Data	Compliance	Description	Data
N/A	Ramp Length (in)	31.0	Yes	Ramp Slope (%)	7.7
No	Ramp Width (in)	44.0	No	Ramp XSlope (%)	5.1
N/A	Flare Type LT	N/A	N/A	Flare Type RT	N/A
N/A	Flare Slope LT (%)	N/A	N/A	Flare Slope RT (%)	N/A
N/A	Flare Traversable LT?	N/A	N/A	Flare Traversable RT?	N/A
N/A	Landing Length (in)	N/A	N/A	DWS Provided?	N/A
N/A	Landing Width (in)	N/A	N/A	DWS Contrast?	N/A
N/A	Landing Slope (%)	N/A	N/A	DWS Length (in)	N/A
N/A	Landing X Slope (%)	N/A	N/A	DWS Full Width?	N/A
N/A	Landing Curb? (Y/N)	N/A	N/A	DWS Offset (in)	N/A
N/A	Shared Landing?	N/A			
N/A	Gutter Ponding?	N/A	N/A	Gutter Slope (%)	N/A
N/A	Gutter Lip Ht (in)	N/A	N/A	Gutter X Slope (%)	N/A
N/A	Painted X Walk1?	No	N/A	Painted X Walk2?	N/A
	X Walk 1 Direction	To NE		X Walk 2 Direction	N/A
N/A	X Walk 1 Width (in)	N/A	N/A	X Walk 2 Width (in)	N/A
	X Walk 1 Slope (%)	5.2		X Walk 2 Slope (%)	N/A
	X Walk 1 X Slope (%)	2.5		X Walk 2 X Slope (%)	N/A

N/A	Ramp inside XWalk1?	N/A	N/A	Ramp inside XWalk2?	N/A
	Road Slope (%)	N/A	N/A	Clear Space?	N/A
	Road X Slope (%)	N/A	N/A	Clear Space to XWalk (in)	N/A
N/A	Any Obstructions?	N/A	N/A	Storm Grate/Utility Hazard?	N/A
	Obstruction Type			Storm Grate/Utility Type	
		N/A			N/A
		Yes		Surface Condition? (G/P)	Good

Possible Solutions:

Remove & Replace Entire Ramp.
