Access Compliance Report

Public Rights-of-Way

(Curb Ramps)

Intersection ID: 51794	Main Street: SUTTONVIEW_DR	Cross Street: BRADY_DR	Location: S
ADA ID: 7BF6F9FFBA3A	Ramp Type: PerpDiag	Initial Pass/Fail: Fail	Overall Compliance: No
Codes/Mitigation Info/Possible Solution		Field Measurements/Component Compliance

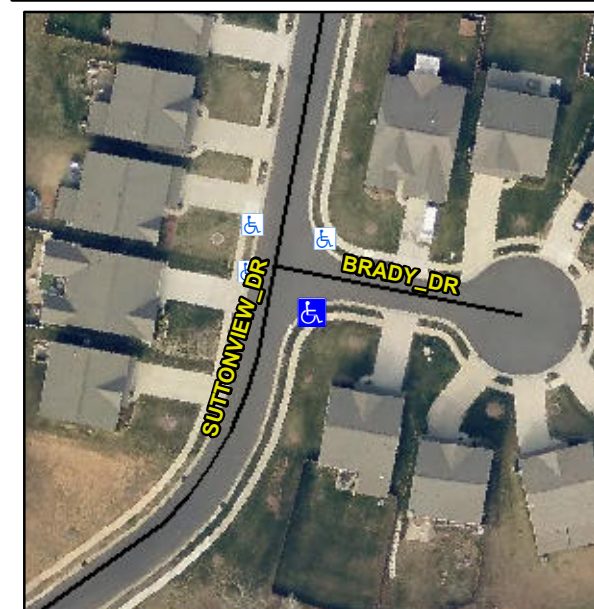
Not Found, R304.5.1, R304.5.3

Compliance	Description	Data	Compliance	Description	Data
N/A	Ramp Length (in)	48.0	Yes	Ramp Slope (%)	7.0
No	Ramp Width (in)	46.0	No	Ramp XSlope (%)	4.1
N/A	Flare Type LT	N/A	N/A	Flare Type RT	N/A
N/A	Flare Slope LT (%)	N/A	N/A	Flare Slope RT (%)	N/A
N/A	Flare Traversable LT?	N/A	N/A	Flare Traversable RT?	N/A
N/A	Landing Length (in)	N/A	N/A	DWS Provided?	N/A
N/A	Landing Width (in)	N/A	N/A	DWS Contrast?	N/A
N/A	Landing Slope (%)	N/A	N/A	DWS Length (in)	N/A
N/A	Landing X Slope (%)	N/A	N/A	DWS Full Width?	N/A
N/A	Landing Curb? (Y/N)	N/A	N/A	DWS Offset (in)	N/A
N/A	Shared Landing?	N/A			
N/A	Gutter Ponding?	N/A	N/A	Gutter Slope (%)	N/A
N/A	Gutter Lip Ht (in)	N/A	N/A	Gutter X Slope (%)	N/A
N/A	Painted X Walk1?	No	N/A	Painted X Walk2?	No
	X Walk 1 Direction	To NE		X Walk 2 Direction	To NW
N/A	X Walk 1 Width (in)	N/A	N/A	X Walk 2 Width (in)	N/A
	X Walk 1 Slope (%)	2.1		X Walk 2 Slope (%)	4.8
	X Walk 1 X Slope (%)	4.6		X Walk 2 X Slope (%)	0.2

N/A	Ramp inside XWalk1?	N/A	N/A	Ramp inside XWalk2?	N/A
	Road Slope (%)	2.9	N/A	Clear Space?	N/A
	Road X Slope (%)	4.1	N/A	Clear Space to XWalk (in)	N/A
N/A	Any Obstructions?	N/A	N/A	Storm Grate/Utility Hazard?	N/A
	Obstruction Type			Storm Grate/Utility Type	
		N/A			N/A
			Yes	Surface Condition? (G/P)	Good

Possible Solutions:

Remove & Replace Curb Ramp With Two New Directional Ramps or Equivalent.
