Access Compliance Report

Public Rights-of-Way

(Curb Ramps)

Intersection ID: 14530	Main Street: E_5TH_ST	Cross Street: N_LAUREL_AV	Location: E
ADA ID: 7BF9BD241E0C	Ramp Type: Perp	Initial Pass/Fail: Fail	Overall Compliance: No
Severity Score: 13.75			
Codes/Mitigation Info/Possible Solution		Field Measurements/Component Compliance

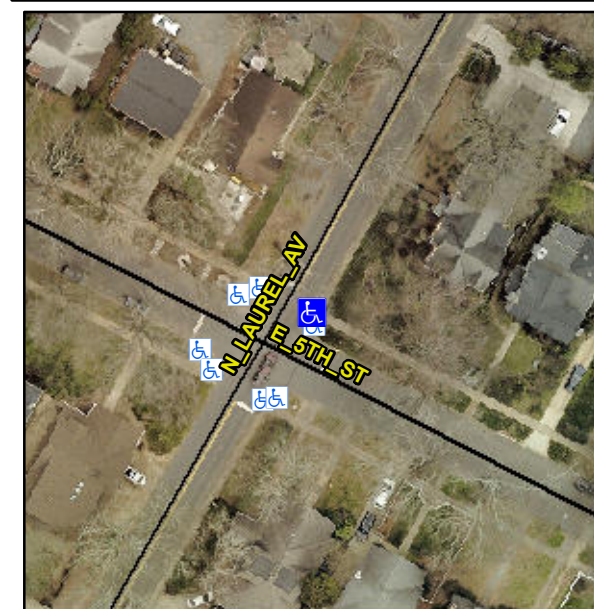
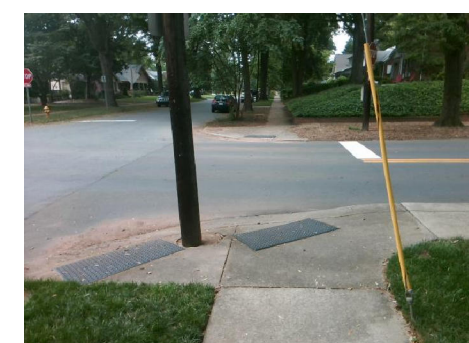
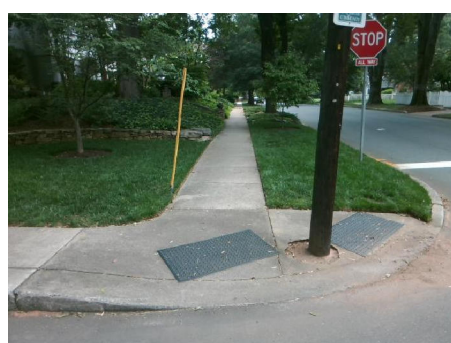
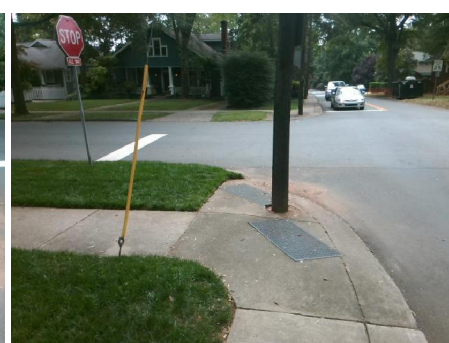
R304.2.2, R304.5.3

Compliance	Description	Data	Compliance	Description	Data
N/A	Ramp Length (in)	60.0	No	Ramp Slope (%)	11.4
Yes	Ramp Width (in)	48.0	No	Ramp XSlope (%)	3.8
N/A	Flare Type LT	N/A	N/A	Flare Type RT	N/A
N/A	Flare Slope LT (%)	N/A	N/A	Flare Slope RT (%)	N/A
N/A	Flare Traversable LT?	N/A	N/A	Flare Traversable RT?	N/A
N/A	Landing Length (in)	N/A	N/A	DWS Provided?	N/A
N/A	Landing Width (in)	N/A	N/A	DWS Contrast?	N/A
N/A	Landing Slope (%)	N/A	N/A	DWS Length (in)	N/A
N/A	Landing X Slope (%)	N/A	N/A	DWS Full Width?	N/A
N/A	Landing Curb? (Y/N)	N/A	N/A	DWS Offset (in)	N/A
N/A	Shared Landing?	N/A			
N/A	Gutter Ponding?	N/A	N/A	Gutter Slope (%)	N/A
N/A	Gutter Lip Ht (in)	N/A	N/A	Gutter X Slope (%)	N/A
N/A	Painted X Walk1?	No	N/A	Painted X Walk2?	N/A
	X Walk 1 Direction	To NW		X Walk 2 Direction	N/A
N/A	X Walk 1 Width (in)	N/A	N/A	X Walk 2 Width (in)	N/A
	X Walk 1 Slope (%)	4.3		X Walk 2 Slope (%)	N/A
	X Walk 1 X Slope (%)	1.4		X Walk 2 X Slope (%)	N/A

N/A	Ramp inside XWalk1?	N/A	N/A	Ramp inside XWalk2?	N/A
	Road Slope (%)	N/A	N/A	Clear Space?	N/A
	Road X Slope (%)	N/A	N/A	Clear Space to XWalk (in)	N/A
N/A	Any Obstructions?	N/A	N/A	Storm Grate/Utility Hazard?	N/A
	Obstruction Type			Storm Grate/Utility Type	
		N/A			N/A
		Yes		Surface Condition? (G/P)	Good

Remove & Replace Entire Ramp.

\$ 1850.00
