Access Compliance Report

Public Rights-of-Way

(Curb Ramps)

Intersection ID: 53224	Main Street: URBAN_PL	Cross Street: GIVENS_WY	Location: SW
ADA ID: 7BFDF7885CFB	Ramp Type: BlendTrans1	Initial Pass/Fail: Fail	Overall Compliance: No
		Severity Score: 8.75

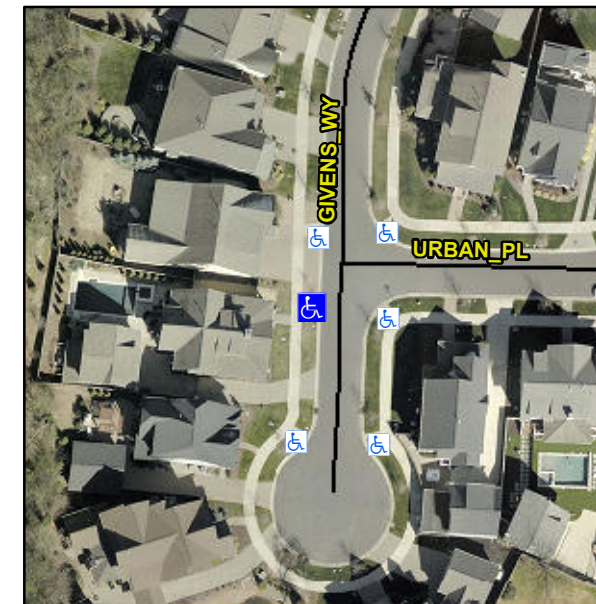
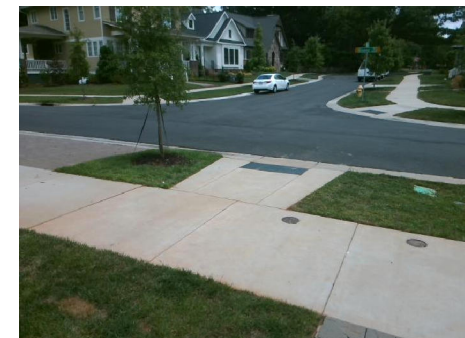
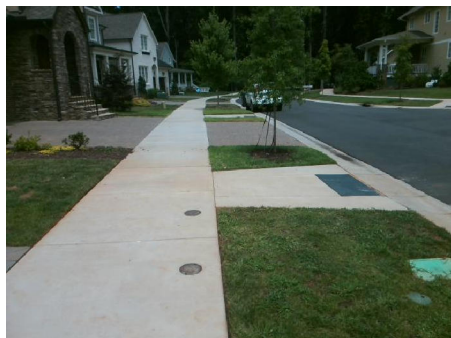
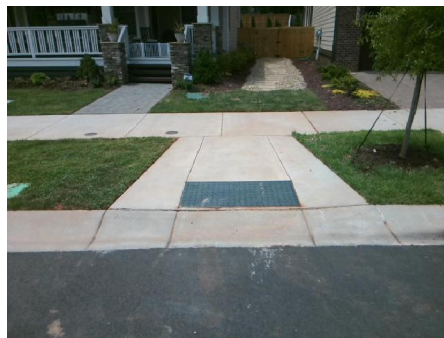
Not Found, R304.5.1

Compliance	Description	Data	Compliance	Description	Data
N/A	Ramp Length (in)	95.5	Yes	BlendTrans Slope (%)	4.0
No	Ramp Width (in)	39.5	Yes	BlendTrans XSlope (%)	1.3
N/A	Flare Type LT	N/A	N/A	Flare Type RT	N/A
N/A	Flare Slope LT (%)	N/A	N/A	Flare Slope RT (%)	N/A
N/A	Flare Traversable LT?	N/A	N/A	Flare Traversable RT?	N/A
N/A	Landing Length (in)	N/A	N/A	DWS Provided?	N/A
N/A	Landing Width (in)	N/A	N/A	DWS Contrast?	N/A
N/A	Landing Slope (%)	N/A	N/A	DWS Length (in)	N/A
N/A	Landing X Slope (%)	N/A	N/A	DWS Full Width?	N/A
N/A	Landing Curb? (Y/N)	N/A	N/A	DWS Offset (in)	N/A
N/A	Shared Landing?	N/A			
N/A	Gutter Ponding?	N/A	N/A	Gutter Slope (%)	N/A
N/A	Gutter Lip Ht (in)	N/A	N/A	Gutter X Slope (%)	N/A
N/A	Painted X Walk1?	No	N/A	Painted X Walk2?	N/A
	X Walk 1 Direction	To E		X Walk 2 Direction	N/A
	X Walk 1 Width (in)	N/A		X Walk 2 Width (in)	N/A
	X Walk 1 Slope (%)	2.1		X Walk 2 Slope (%)	N/A
	X Walk 1 X Slope (%)	1.1		X Walk 2 X Slope (%)	N/A

N/A	Ramp inside XWalk1?	N/A	N/A	Ramp inside XWalk2?	N/A
	Road Slope (%)	1.1		Clear Space?	N/A
	Road X Slope (%)	2.1	N/A	Clear Space to XWalk (in)	N/A
N/A	Any Obstructions?	N/A	N/A	Storm Grate/Utility Hazard?	N/A
	Obstruction Type			Storm Grate/Utility Type	
		N/A			N/A
			Yes	Surface Condition? (G/P)	Good
			No	Curb Slope (%)	11.7

Remove & Replace Curb Ramp With Two New Directional Ramps or Equivalent.
