Access Compliance Report

Public Rights-of-Way

(Curb Ramps)

Intersection ID: 43869	Main Street: CALDWELL_RIDGE_PY	Cross Street: SIDNEY_CREST_AV	Location: SW
ADA ID: 7C07BA7DC791	Ramp Type: Perp	Initial Pass/Fail: Fail	Overall Compliance: No
Severity Score: 21.25			
Codes/Mitigation Info/Possible Solution		Field Measurements/Component Compliance

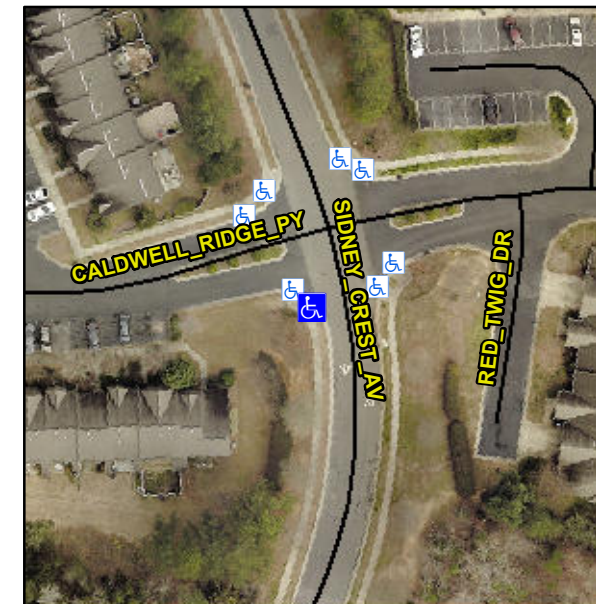
PROW/ADA:

Not Found, R304.5.1, R304.5.3

Compliance	Description	Data	Compliance	Description	Data
N/A	Ramp Length (in)	48.5	Yes	Ramp Slope (%)	5.7
No	Ramp Width (in)	40.5	No	Ramp XSlope (%)	5.1
N/A	Flare Type LT	N/A	N/A	Flare Type RT	N/A
N/A	Flare Slope LT (%)	N/A	N/A	Flare Slope RT (%)	N/A
N/A	Flare Traversable LT?	N/A	N/A	Flare Traversable RT?	N/A
N/A	Landing Length (in)	N/A	N/A	DWS Provided?	N/A
N/A	Landing Width (in)	N/A	N/A	DWS Contrast?	N/A
N/A	Landing Slope (%)	N/A	N/A	DWS Length (in)	N/A
N/A	Landing X Slope (%)	N/A	N/A	DWS Full Width?	N/A
N/A	Landing Curb? (Y/N)	N/A	N/A	DWS Offset (in)	N/A
N/A	Shared Landing?	N/A			
N/A	Gutter Ponding?	N/A	N/A	Gutter Slope (%)	N/A
N/A	Gutter Lip Ht (in)	N/A	N/A	Gutter X Slope (%)	N/A
N/A	Painted X Walk1?	No	N/A	Painted X Walk2?	N/A
	X Walk 1 Direction	To E		X Walk 2 Direction	N/A
N/A	X Walk 1 Width (in)	N/A	N/A	X Walk 2 Width (in)	N/A
	X Walk 1 Slope (%)	1.0		X Walk 2 Slope (%)	N/A
	X Walk 1 X Slope (%)	2.1		X Walk 2 X Slope (%)	N/A

N/A	Ramp inside XWalk1?	N/A	N/A	Ramp inside XWalk2?	N/A
	Road Slope (%)	N/A	N/A	Clear Space?	N/A
	Road X Slope (%)	N/A	N/A	Clear Space to XWalk (in)	N/A
N/A	Any Obstructions?	N/A	N/A	Storm Grate/Utility Hazard?	N/A
	Obstruction Type			Storm Grate/Utility Type	
		N/A			N/A
			Yes	Surface Condition? (G/P)	Good

Possible Solutions:

Remove & Replace Entire Ramp.

Total Cost: \$ 1850.00
