# Access Compliance Report

## Public Rights-of-Way

### (Curb Ramps)

Intersection ID: 10015694	Main Street: IKEA_BV	Cross Street: N/A	Location: NW
ADA ID: 7C1488493D17	Ramp Type: Perp	Initial Pass/Fail: Fail	Overall Compliance: No
Severity Score: 21.25			
Codes/Mitigation Info/Possible Solution		Field Measurements/Component Compliance

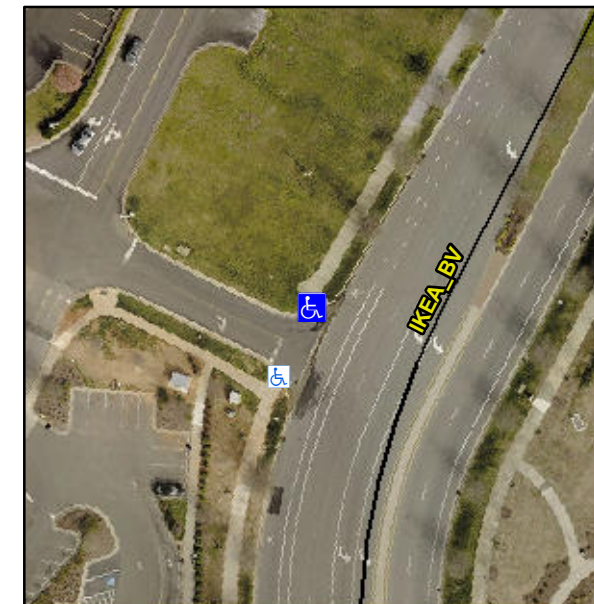
Compliance	Description	Data	Compliance	Description	Data
N/A	Ramp Length (in)	97.0	No	Ramp Slope (%)	9.6
No	Ramp Width (in)	44.0	Yes	Ramp XSlope (%)	1.8
N/A	Flare Type LT	N/A	N/A	Flare Type RT	N/A
N/A	Flare Slope LT (%)	N/A	N/A	Flare Slope RT (%)	N/A
N/A	Flare Traversable LT?	N/A	N/A	Flare Traversable RT?	N/A
N/A	Landing Length (in)	N/A	N/A	DWS Provided?	N/A
N/A	Landing Width (in)	N/A	N/A	DWS Contrast?	N/A
N/A	Landing Slope (%)	N/A	N/A	DWS Length (in)	N/A
N/A	Landing X Slope (%)	N/A	N/A	DWS Full Width?	N/A
N/A	Landing Curb? (Y/N)	N/A	N/A	DWS Offset (in)	N/A
N/A	Shared Landing?	N/A			
N/A	Gutter Ponding?	N/A	N/A	Gutter Slope (%)	N/A
N/A	Gutter Lip Ht (in)	N/A	N/A	Gutter X Slope (%)	N/A
N/A	Painted X Walk1?	No	N/A	Painted X Walk2?	N/A
	X Walk 1 Direction	To S		X Walk 2 Direction	N/A
N/A	X Walk 1 Width (in)	N/A	N/A	X Walk 2 Width (in)	N/A
	X Walk 1 Slope (%)	3.3		X Walk 2 Slope (%)	N/A
	X Walk 1 X Slope (%)	0.6		X Walk 2 X Slope (%)	N/A

N/A	Ramp inside XWalk1?	N/A	N/A	Ramp inside XWalk2?	N/A
	Road Slope (%)	N/A	N/A	Clear Space?	N/A
	Road X Slope (%)	N/A	N/A	Clear Space to XWalk (in)	N/A
N/A	Any Obstructions?	N/A	N/A	Storm Grate/Utility Hazard?	N/A
	Obstruction Type			Storm Grate/Utility Type	
		N/A			N/A
			Yes	Surface Condition? (G/P)	Good

**Remove & Replace Entire Ramp.**

**R304.5.1, R304.2.2**

Total Cost: \$ 1850.00
