Access Compliance Report

Public Rights-of-Way

(Curb Ramps)

Intersection ID: 18776	Main Street: SOUTH_BV	Cross Street: TYVOLA_RD	Location: NW
ADA ID: 7C222EFC50DD	Ramp Type: PerpDiag	Initial Pass/Fail: Fail	Overall Compliance: No
		Severity Score: 12.5

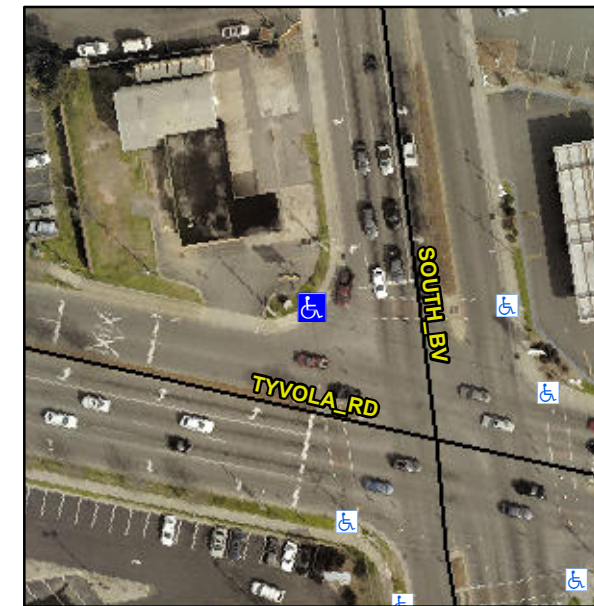
Compliance	Description	Data	Compliance	Description	Data
N/A	Ramp Length (in)	71.0	No	Ramp Slope (%)	9.0
Yes	Ramp Width (in)	48.0	Yes	Ramp XSlope (%)	1.1
N/A	Flare Type LT	N/A	N/A	Flare Type RT	N/A
N/A	Flare Slope LT (%)	N/A	N/A	Flare Slope RT (%)	N/A
N/A	Flare Traversable LT?	N/A	N/A	Flare Traversable RT?	N/A
N/A	Landing Length (in)	N/A	N/A	DWS Provided?	N/A
N/A	Landing Width (in)	N/A	N/A	DWS Contrast?	N/A
N/A	Landing Slope (%)	N/A	N/A	DWS Length (in)	N/A
N/A	Landing X Slope (%)	N/A	N/A	DWS Full Width?	N/A
N/A	Landing Curb? (Y/N)	N/A	N/A	DWS Offset (in)	N/A
N/A	Shared Landing?	N/A			
N/A	Gutter Ponding?	N/A	N/A	Gutter Slope (%)	N/A
N/A	Gutter Lip Ht (in)	N/A	N/A	Gutter X Slope (%)	N/A
N/A	Painted X Walk1?	Yes	N/A	Painted X Walk2?	Yes
	X Walk 1 Direction	To S		X Walk 2 Direction	To E
N/A	X Walk 1 Width (in)	109.0	N/A	X Walk 2 Width (in)	122.0
	X Walk 1 Slope (%)	1.3		X Walk 2 Slope (%)	1.6
	X Walk 1 X Slope (%)	0.8		X Walk 2 X Slope (%)	1.3

N/A	Ramp inside XWalk1?	Yes	N/A	Ramp inside XWalk2?	Yes
	Road Slope (%)	0.4	N/A	Clear Space?	N/A
	Road X Slope (%)	2.2	N/A	Clear Space to XWalk (in)	N/A
N/A	Any Obstructions?	N/A	N/A	Storm Grate/Utility Hazard?	N/A
	Obstruction Type			Storm Grate/Utility Type	
		N/A			N/A
		Yes		Surface Condition? (G/P)	Good

Possible Solutions:

Remove & Replace Curb Ramp With Two New Directional Ramps or Equivalent.

R304.2.2
