# Access Compliance Report

## Public Rights-of-Way

### (Curb Ramps)

Intersection ID: 7665	Main Street: GLENMOOR_DR	Cross Street: TOMAHAWK_LN	Location:	N
ADA ID: 7C2318AD71BD	Ramp Type: Perp	Initial Pass/Fail: Fail	Overall Compliance: No	Severity Score: 8.75
Codes/Mitigation Info/Possible Solution		Field Measurements/Component Compliance

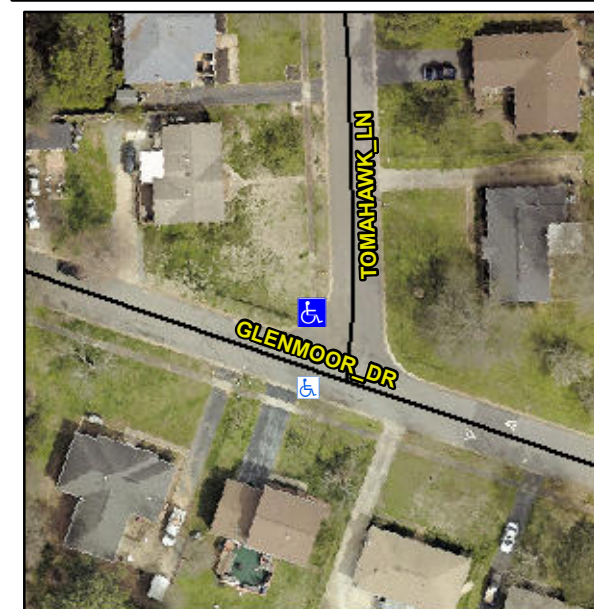
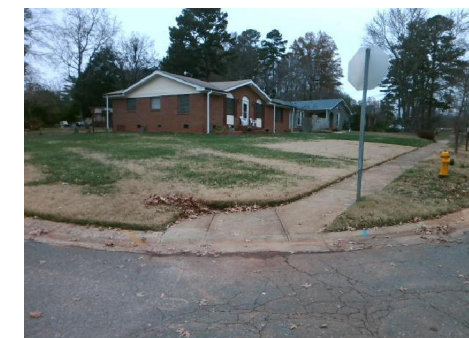
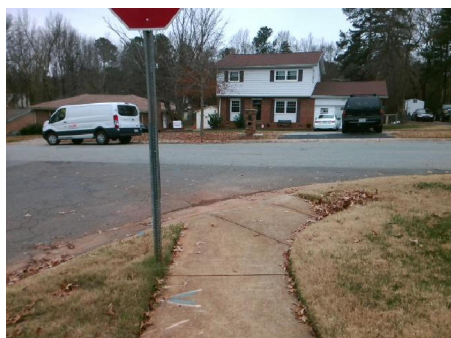
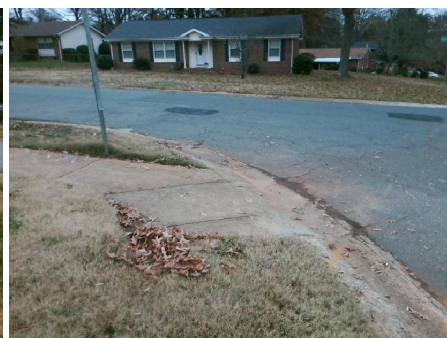
**Not Found, R304.5.1**

Compliance	Description	Data	Compliance	Description	Data
N/A	Ramp Length (in)	61.0	Yes	Ramp Slope (%)	7.9
No	Ramp Width (in)	44.0	Yes	Ramp XSlope (%)	0.9
N/A	Flare Type LT	N/A	N/A	Flare Type RT	N/A
N/A	Flare Slope LT (%)	N/A	N/A	Flare Slope RT (%)	N/A
N/A	Flare Traversable LT?	N/A	N/A	Flare Traversable RT?	N/A
N/A	Landing Length (in)	N/A	N/A	DWS Provided?	N/A
N/A	Landing Width (in)	N/A	N/A	DWS Contrast?	N/A
N/A	Landing Slope (%)	N/A	N/A	DWS Length (in)	N/A
N/A	Landing X Slope (%)	N/A	N/A	DWS Full Width?	N/A
N/A	Landing Curb? (Y/N)	N/A	N/A	DWS Offset (in)	N/A
N/A	Shared Landing?	N/A			
N/A	Gutter Ponding?	N/A	N/A	Gutter Slope (%)	N/A
N/A	Gutter Lip Ht (in)	N/A	N/A	Gutter X Slope (%)	N/A
N/A	Painted X Walk1?	No	N/A	Painted X Walk2?	N/A
	X Walk 1 Direction	To S		X Walk 2 Direction	N/A
N/A	X Walk 1 Width (in)	N/A	N/A	X Walk 2 Width (in)	N/A
	X Walk 1 Slope (%)	0.3		X Walk 2 Slope (%)	N/A
	X Walk 1 X Slope (%)	3.1		X Walk 2 X Slope (%)	N/A

N/A	Ramp inside XWalk1?	N/A	N/A	Ramp inside XWalk2?	N/A
	Road Slope (%)	N/A	N/A	Clear Space?	N/A
	Road X Slope (%)	N/A	N/A	Clear Space to XWalk (in)	N/A
N/A	Any Obstructions?	N/A	N/A	Storm Grate/Utility Hazard?	N/A
	Obstruction Type			Storm Grate/Utility Type	
		N/A			N/A
			Yes	Surface Condition? (G/P)	Good

**Remove & Replace Entire Ramp.**

Total Cost: \$ 1850.00
