Access Compliance Report

Public Rights-of-Way

(Curb Ramps)

Intersection ID: N/A	Main Street: PHILLIPS_PLACE_CT	Cross Street: CAMERON_VALLEY_PY	Location: NE
ADA ID: 7C2E6A207688	Ramp Type: Perp	Initial Pass/Fail: Fail	Overall Compliance: No
Codes/Mitigation Info/Possible Solution		Field Measurements/Component Compliance	
Severity Score: 12.5

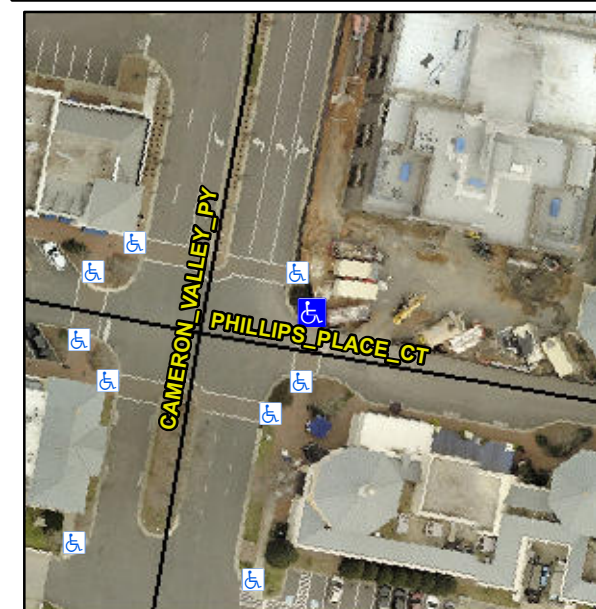
Compliance	Description	Data	Compliance	Description	Data
N/A	Ramp Length (in)	37.0	Yes	Ramp Slope (%)	5.3
Yes	Ramp Width (in)	145.0	No	Ramp XSlope (%)	5.2
N/A	Flare Type LT	N/A	N/A	Flare Type RT	N/A
N/A	Flare Slope LT (%)	N/A	N/A	Flare Slope RT (%)	N/A
N/A	Flare Traversable LT?	N/A	N/A	Flare Traversable RT?	N/A
N/A	Landing Length (in)	N/A	N/A	DWS Provided?	N/A
N/A	Landing Width (in)	N/A	N/A	DWS Contrast?	N/A
N/A	Landing Slope (%)	N/A	N/A	DWS Length (in)	N/A
N/A	Landing X Slope (%)	N/A	N/A	DWS Full Width?	N/A
N/A	Landing Curb? (Y/N)	N/A	N/A	DWS Offset (in)	N/A
N/A	Shared Landing?	N/A			
N/A	Gutter Ponding?	N/A	N/A	Gutter Slope (%)	N/A
N/A	Gutter Lip Ht (in)	1.0	N/A	Gutter X Slope (%)	N/A
N/A	Painted X Walk1?	Yes	N/A	Painted X Walk2?	N/A
	X Walk 1 Direction	To SW		X Walk 2 Direction	N/A
N/A	X Walk 1 Width (in)	146.0	N/A	X Walk 2 Width (in)	N/A
	X Walk 1 Slope (%)	0.0		X Walk 2 Slope (%)	N/A
	X Walk 1 X Slope (%)	2.7		X Walk 2 X Slope (%)	N/A

N/A	Ramp inside XWalk1?	Yes	N/A	Ramp inside XWalk2?	N/A
	Road Slope (%)	N/A	N/A	Clear Space?	N/A
	Road X Slope (%)	N/A	N/A	Clear Space to XWalk (in)	N/A
N/A	Any Obstructions?	N/A	N/A	Storm Grate/Utility Hazard?	N/A
	Obstruction Type			Storm Grate/Utility Type	
		N/A			N/A
			Yes	Surface Condition? (G/P)	Good

Remove & Replace Entire Ramp.

R304.5.3
