Access Compliance Report

Public Rights-of-Way

(Curb Ramps)

Intersection ID: 12400	Main Street: BELVEDERE_AV	Cross Street: ST_ANDREWS_LN	Location: SE
ADA ID: 7C3BF20804E1	Ramp Type: Perp	Initial Pass/Fail: Fail	Overall Compliance: No
		Severity Score: 47.5

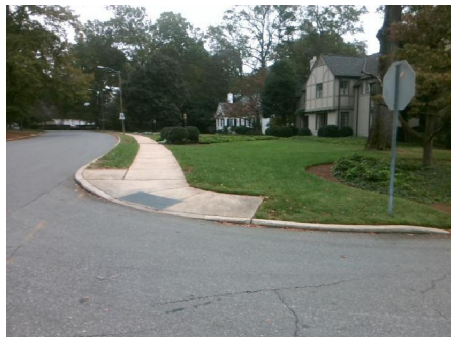
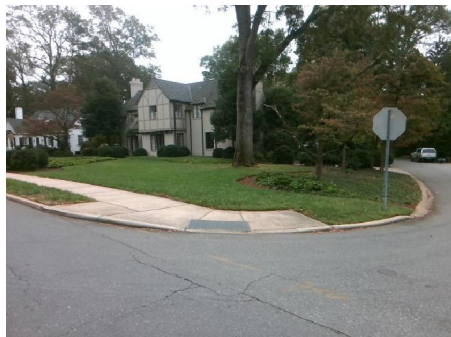
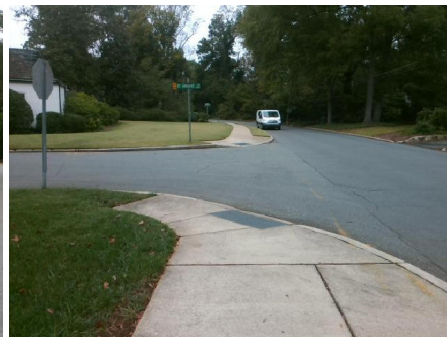
Compliance	Description	Data	Compliance	Description	Data
N/A	Ramp Length (in)	62.5	Yes	Ramp Slope (%)	6.8
No	Ramp Width (in)	26.0	No	Ramp XSlope (%)	6.7
N/A	Flare Type LT	N/A	N/A	Flare Type RT	N/A
N/A	Flare Slope LT (%)	N/A	N/A	Flare Slope RT (%)	N/A
N/A	Flare Traversable LT?	N/A	N/A	Flare Traversable RT?	N/A
N/A	Landing Length (in)	N/A	N/A	DWS Provided?	N/A
N/A	Landing Width (in)	N/A	N/A	DWS Contrast?	N/A
N/A	Landing Slope (%)	N/A	N/A	DWS Length (in)	N/A
N/A	Landing X Slope (%)	N/A	N/A	DWS Full Width?	N/A
N/A	Landing Curb? (Y/N)	N/A	N/A	DWS Offset (in)	N/A
N/A	Shared Landing?	N/A			
N/A	Gutter Ponding?	N/A	N/A	Gutter Slope (%)	N/A
N/A	Gutter Lip Ht (in)	N/A	N/A	Gutter X Slope (%)	N/A
N/A	Painted X Walk1?	No	N/A	Painted X Walk2?	N/A
	X Walk 1 Direction	To W		X Walk 2 Direction	N/A
N/A	X Walk 1 Width (in)	N/A	N/A	X Walk 2 Width (in)	N/A
	X Walk 1 Slope (%)	2.4		X Walk 2 Slope (%)	N/A
	X Walk 1 X Slope (%)	6.2		X Walk 2 X Slope (%)	N/A

N/A	Ramp inside XWalk1?	N/A	N/A	Ramp inside XWalk2?	N/A
	Road Slope (%)	6.2	N/A	Clear Space?	N/A
	Road X Slope (%)	2.4	N/A	Clear Space to XWalk (in)	N/A
N/A	Any Obstructions?	N/A	N/A	Storm Grate/Utility Hazard?	N/A
	Obstruction Type			Storm Grate/Utility Type	
		N/A			N/A
			Yes	Surface Condition? (G/P)	Good

Remove & Replace Entire Ramp.
