Access Compliance Report

Public Rights-of-Way

(Curb Ramps)

Intersection ID: 22498	Main Street: WESTINGHOUSE_BV	Cross Street: BROOKFORD_ST	Location: NW
ADA ID: 7C4787DE50FC	Ramp Type: Para	Initial Pass/Fail: Fail	Overall Compliance: No
Codes/Mitigation Info/Possible Solution		Field Measurements/Component Compliance	
Severity Score: 26.25

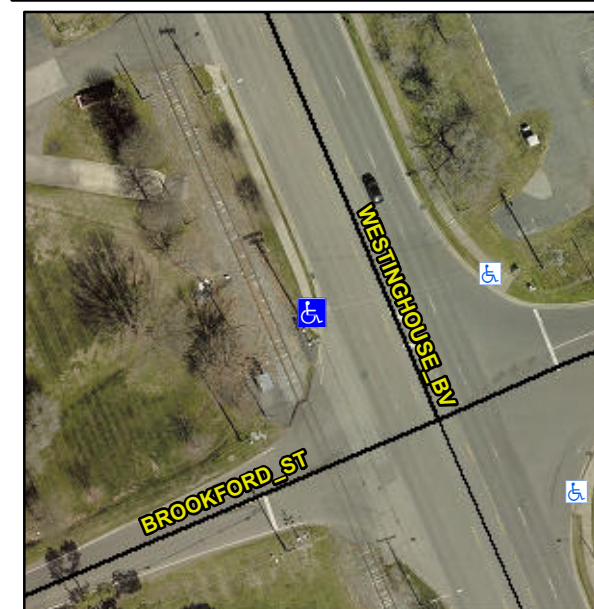
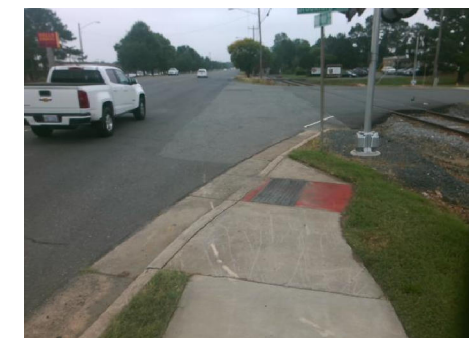
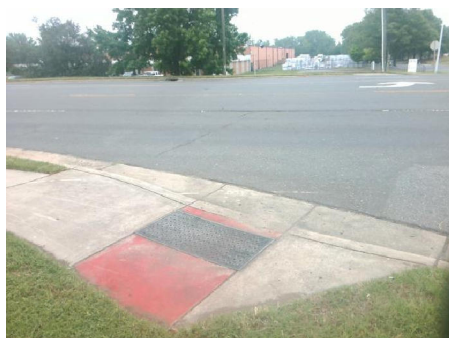
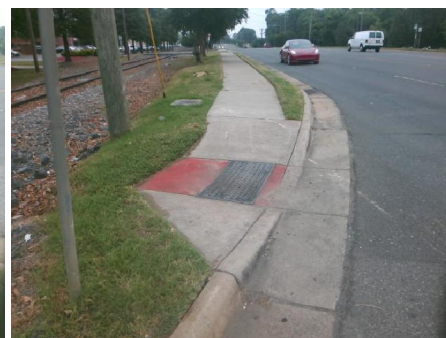
R304.5.3, R304.3.2

Compliance	Description	Data	Compliance	Description	Data
N/A	Ramp Length LT (in)	44.0	N/A	Ramp Length RT (in)	80.0
Yes	Ramp Width LT (in)	59.0	Yes	Ramp Width RT (in)	59.0
Yes	Ramp Slope LT (%)	7.1	No	Ramp Slope RT (%)	13.8
No	Ramp XSlope LT (%)	2.1	Yes	Ramp XSlope RT (%)	2.0
N/A	Landing Length (in)	N/A	N/A	DWS Provided?	N/A
N/A	Landing Width (in)	N/A	N/A	DWS Contrast?	N/A
N/A	Landing Slope (%)	N/A	N/A	DWS Length (in)	N/A
N/A	Landing X Slope (%)	N/A	N/A	DWS Full Width?	N/A
N/A	Landing Curb? (Y/N)	N/A	N/A	DWS Offset (in)	N/A
N/A	Shared Landing?	N/A			
N/A	Gutter Ponding?	N/A	N/A	Gutter Slope (%)	N/A
N/A	Gutter Lip Ht (in)	N/A	N/A	Gutter X Slope (%)	N/A
N/A	Painted X Walk1?	No	N/A	Painted X Walk2?	N/A
	X Walk 1 Direction	To E		X Walk 2 Direction	N/A
N/A	X Walk 1 Width (in)	N/A	N/A	X Walk 2 Width (in)	N/A
	X Walk 1 Slope (%)	4.2		X Walk 2 Slope (%)	N/A
	X Walk 1 X Slope (%)	2.4		X Walk 2 X Slope (%)	N/A
N/A	Ramp inside XWalk1?	N/A	N/A	Ramp inside XWalk2?	N/A

Road Slope (%)	N/A	N/A	Clear Space?	N/A
	Road X Slope (%)	N/A	N/A	Clear Space to XWalk (in)	N/A
N/A	Any Obstructions?	N/A	N/A	Storm Grate/Utility Hazard?	N/A
	Obstruction Type			Storm Grate/Utility Type	
		N/A			N/A
			Yes	Surface Condition? (G/P)	Good
			N/A	Curb Slope (%)	0.1

Remove & Replace Entire Ramp.

Total Cost: \$ 1600.00
