# Access Compliance Report

## Public Rights-of-Way

### (Curb Ramps)

Intersection ID: 4659	Main Street: ASTORIA_DR	Cross Street: HARRIS_HOUSTON_RD	Location: W
ADA ID: 7C4FABBCFB76	Ramp Type: Perp	Initial Pass/Fail: Fail	Overall Compliance: No
Severity Score: 37.5			
Codes/Mitigation Info/Possible Solution		Field Measurements/Component Compliance

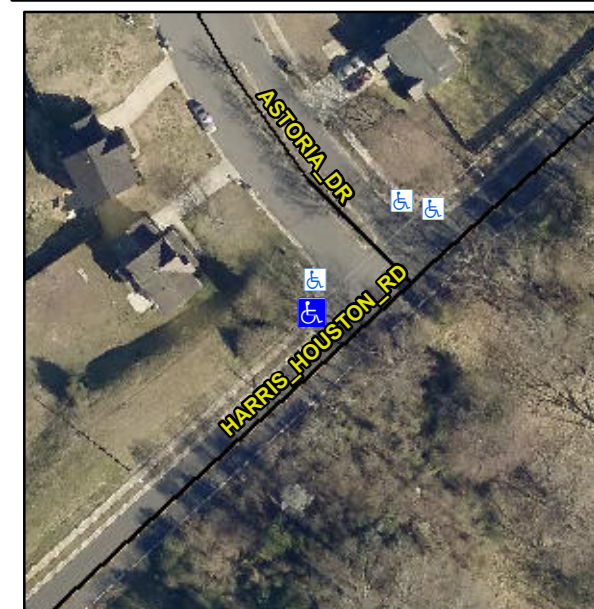
Compliance	Description	Data	Compliance	Description	Data
N/A	Ramp Length (in)	96.0	No	Ramp Slope (%)	8.6
Yes	Ramp Width (in)	48.0	No	Ramp XSlope (%)	15.0
N/A	Flare Type LT	N/A	N/A	Flare Type RT	N/A
N/A	Flare Slope LT (%)	N/A	N/A	Flare Slope RT (%)	N/A
N/A	Flare Traversable LT?	N/A	N/A	Flare Traversable RT?	N/A
N/A	Landing Length (in)	N/A	N/A	DWS Provided?	N/A
N/A	Landing Width (in)	N/A	N/A	DWS Contrast?	N/A
N/A	Landing Slope (%)	N/A	N/A	DWS Length (in)	N/A
N/A	Landing X Slope (%)	N/A	N/A	DWS Full Width?	N/A
N/A	Landing Curb? (Y/N)	N/A	N/A	DWS Offset (in)	N/A
N/A	Shared Landing?	N/A			
N/A	Gutter Ponding?	N/A	N/A	Gutter Slope (%)	N/A
N/A	Gutter Lip Ht (in)	N/A	N/A	Gutter X Slope (%)	N/A
N/A	Painted X Walk1?	No	N/A	Painted X Walk2?	N/A
	X Walk 1 Direction	To SE		X Walk 2 Direction	N/A
N/A	X Walk 1 Width (in)	N/A	N/A	X Walk 2 Width (in)	N/A
	X Walk 1 Slope (%)	3.9		X Walk 2 Slope (%)	N/A
	X Walk 1 X Slope (%)	14.8		X Walk 2 X Slope (%)	N/A

N/A	Ramp inside XWalk1?	N/A	N/A	Ramp inside XWalk2?	N/A
	Road Slope (%)	N/A	N/A	Clear Space?	N/A
	Road X Slope (%)	N/A	N/A	Clear Space to XWalk (in)	N/A
N/A	Any Obstructions?	N/A	N/A	Storm Grate/Utility Hazard?	N/A
	Obstruction Type			Storm Grate/Utility Type	
		N/A			N/A
			Yes	Surface Condition? (G/P)	Good

**Remove & Replace Entire Ramp.**

**R304.2.2, R304.5.3**
