Access Compliance Report

Public Rights-of-Way

(Curb Ramps)

Intersection ID: 18914	Main Street: S_I-77_EXIT_5_RA	Cross Street: TYVOLA_RD	Location: S
ADA ID: 7C51594EDF27	Ramp Type: Perp	Initial Pass/Fail: Fail	Overall Compliance: No
		Severity Score: 12.5

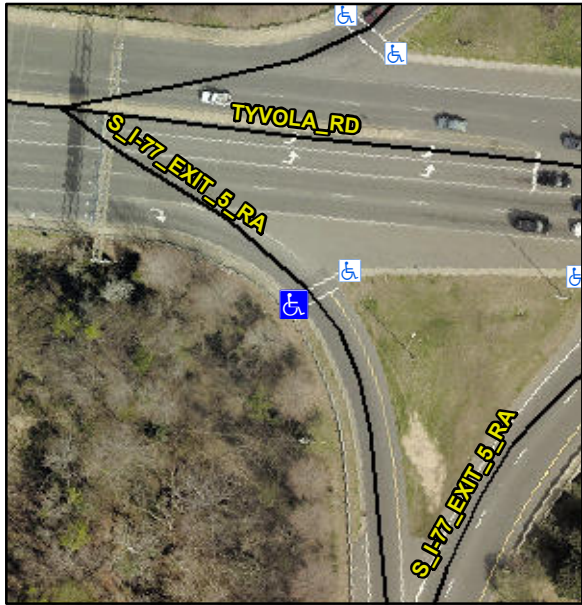
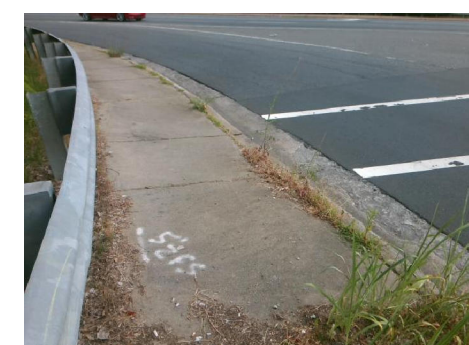
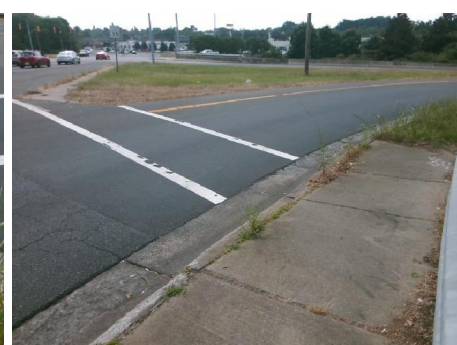
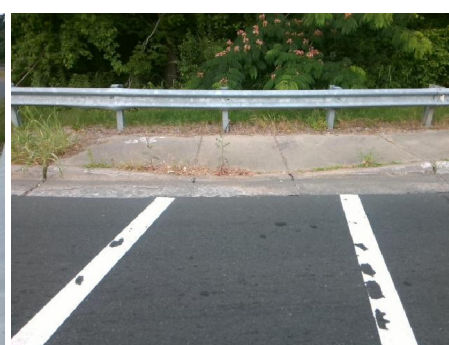
Possible Solutions:		Compliance	Description	Data	Compliance	Description	Data
	Remove & Replace Entire Ramp.		N/A	Ramp Length (in)	62.0	No	Ramp Slope (%)	9.3
			Yes	Ramp Width (in)	49.0	Yes	Ramp XSlope (%)	0.9
			N/A	Flare Type LT	N/A	N/A	Flare Type RT	N/A
			N/A	Flare Slope LT (%)	N/A	N/A	Flare Slope RT (%)	N/A
			N/A	Flare Traversable LT?	N/A	N/A	Flare Traversable RT?	N/A
			N/A	Landing Length (in)	N/A	N/A	DWS Provided?	N/A
			N/A	Landing Width (in)	N/A	N/A	DWS Contrast?	N/A
			N/A	Landing Slope (%)	N/A	N/A	DWS Length (in)	N/A
			N/A	Landing X Slope (%)	N/A	N/A	DWS Full Width?	N/A
Surveyor Notes:		N/A	N/A	Landing Curb? (Y/N)	N/A	N/A	DWS Offset (in)	N/A
PROW/ADA:		Not Found, R304.2.2	N/A	Shared Landing?	N/A			
			N/A	Gutter Ponding?	N/A	N/A	Gutter Slope (%)	N/A
			N/A	Gutter Lip Ht (in)	N/A	N/A	Gutter X Slope (%)	N/A

N/A	Painted X Walk1?	Yes	N/A	Painted X Walk2?	N/A
				X Walk 1 Direction	To NE		X Walk 2 Direction	N/A
			N/A	X Walk 1 Width (in)	72.0	N/A	X Walk 2 Width (in)	N/A
				X Walk 1 Slope (%)	3.8		X Walk 2 Slope (%)	N/A
				X Walk 1 X Slope (%)	2.8		X Walk 2 X Slope (%)	N/A
			N/A	Ramp inside XWalk1?	Yes	N/A	Ramp inside XWalk2?	N/A
				Road Slope (%)	N/A	N/A	Clear Space?	N/A
				Road X Slope (%)	N/A	N/A	Clear Space to XWalk (in)	N/A
			N/A	Any Obstructions?	N/A	N/A	Storm Grate/Utility Hazard?	N/A
				Obstruction Type			Storm Grate/Utility Type	
					N/A			N/A
						Yes	Surface Condition? (G/P)	Good
Total Cost:		\$ 1850.00						
Street 1 Name		S I-77 EXIT 5 RA						
Stop Condition-Street 2		None						
Street 2 Name		N/A						
Stop Condition-Street 1		N/A
