Access Compliance Report

Public Rights-of-Way

(Curb Ramps)

Intersection ID: N/A	Main Street: IDLEWILD_RD	Cross Street: E_INDEPENDENCE_RA	Location: SW
ADA ID: 7C5F2454BEAD	Ramp Type: Perp	Initial Pass/Fail: Fail	Overall Compliance: No
		Severity Score: 12.5

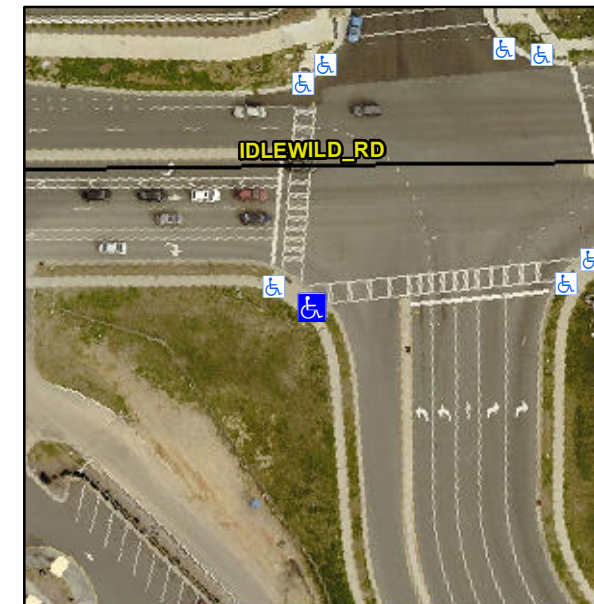
Compliance	Description	Data	Compliance	Description	Data
N/A	Ramp Length (in)	65.0	No	Ramp Slope (%)	8.7
Yes	Ramp Width (in)	59.0	Yes	Ramp XSlope (%)	1.4
N/A	Flare Type LT	N/A	N/A	Flare Type RT	N/A
N/A	Flare Slope LT (%)	N/A	N/A	Flare Slope RT (%)	N/A
N/A	Flare Traversable LT?	N/A	N/A	Flare Traversable RT?	N/A
N/A	Landing Length (in)	N/A	N/A	DWS Provided?	N/A
N/A	Landing Width (in)	N/A	N/A	DWS Contrast?	N/A
N/A	Landing Slope (%)	N/A	N/A	DWS Length (in)	N/A
N/A	Landing X Slope (%)	N/A	N/A	DWS Full Width?	N/A
N/A	Landing Curb? (Y/N)	N/A	N/A	DWS Offset (in)	N/A
N/A	Shared Landing?	N/A			
N/A	Gutter Ponding?	N/A	N/A	Gutter Slope (%)	N/A
N/A	Gutter Lip Ht (in)	N/A	N/A	Gutter X Slope (%)	N/A
N/A	Painted X Walk1?	Yes	N/A	Painted X Walk2?	N/A
	X Walk 1 Direction	To E		X Walk 2 Direction	N/A
N/A	X Walk 1 Width (in)	110.0	N/A	X Walk 2 Width (in)	N/A
	X Walk 1 Slope (%)	6.1		X Walk 2 Slope (%)	N/A
	X Walk 1 X Slope (%)	1.5		X Walk 2 X Slope (%)	N/A

N/A	Ramp inside XWalk1?	Yes	N/A	Ramp inside XWalk2?	N/A
	Road Slope (%)	N/A	N/A	Clear Space?	N/A
	Road X Slope (%)	N/A	N/A	Clear Space to XWalk (in)	N/A
N/A	Any Obstructions?	N/A	N/A	Storm Grate/Utility Hazard?	N/A
	Obstruction Type			Storm Grate/Utility Type	
		N/A			N/A
			Yes	Surface Condition? (G/P)	Good

Remove & Replace Entire Ramp.

Not Found, R304.2.2
