Access Compliance Report

Public Rights-of-Way

(Curb Ramps)

Intersection ID: 14705	Main Street: ALBEMARLE_RD	Cross Street: LYNTON_BV	Location: SW
ADA ID: 7C625A220BFC	Ramp Type: Perp	Initial Pass/Fail: Fail	Overall Compliance: No
Severity Score: 21.25			
Codes/Mitigation Info/Possible Solution		Field Measurements/Component Compliance

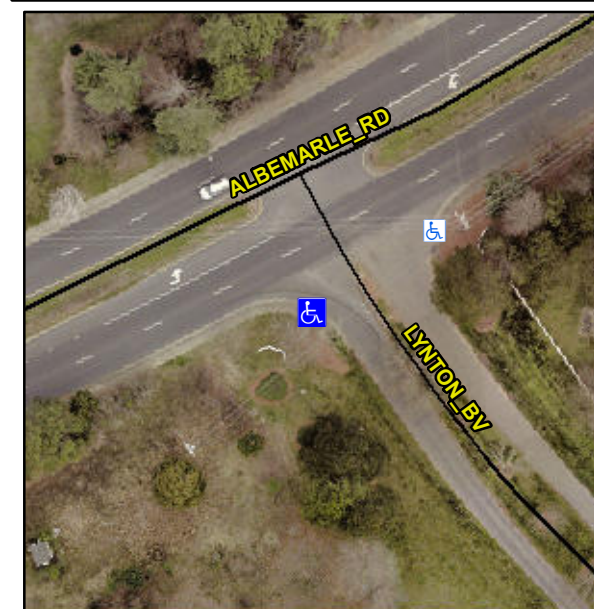
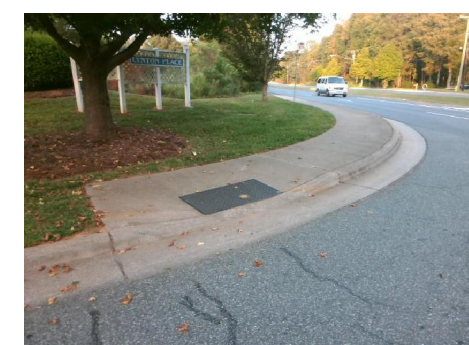
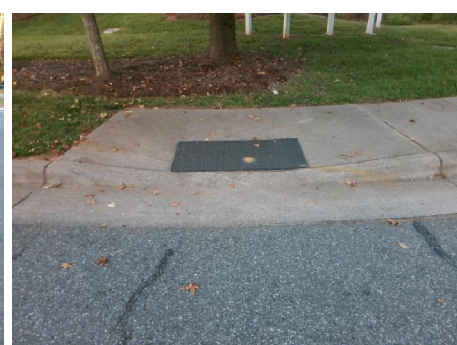
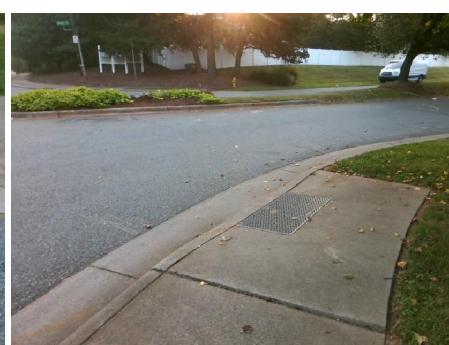
Not Found, R304.5.1, R304.2.2

Compliance	Description	Data	Compliance	Description	Data
N/A	Ramp Length (in)	60.5	No	Ramp Slope (%)	9.3
No	Ramp Width (in)	45.0	Yes	Ramp XSlope (%)	1.0
N/A	Flare Type LT	N/A	N/A	Flare Type RT	N/A
N/A	Flare Slope LT (%)	N/A	N/A	Flare Slope RT (%)	N/A
N/A	Flare Traversable LT?	N/A	N/A	Flare Traversable RT?	N/A
N/A	Landing Length (in)	N/A	N/A	DWS Provided?	N/A
N/A	Landing Width (in)	N/A	N/A	DWS Contrast?	N/A
N/A	Landing Slope (%)	N/A	N/A	DWS Length (in)	N/A
N/A	Landing X Slope (%)	N/A	N/A	DWS Full Width?	N/A
N/A	Landing Curb? (Y/N)	N/A	N/A	DWS Offset (in)	N/A
N/A	Shared Landing?	N/A			
N/A	Gutter Ponding?	N/A	N/A	Gutter Slope (%)	N/A
N/A	Gutter Lip Ht (in)	N/A	N/A	Gutter X Slope (%)	N/A
N/A	Painted X Walk1?	No	N/A	Painted X Walk2?	N/A
	X Walk 1 Direction	To E		X Walk 2 Direction	N/A
N/A	X Walk 1 Width (in)	N/A	N/A	X Walk 2 Width (in)	N/A
	X Walk 1 Slope (%)	2.7		X Walk 2 Slope (%)	N/A
	X Walk 1 X Slope (%)	0.6		X Walk 2 X Slope (%)	N/A

N/A	Ramp inside XWalk1?	N/A	N/A	Ramp inside XWalk2?	N/A
	Road Slope (%)	N/A	N/A	Clear Space?	N/A
	Road X Slope (%)	N/A	N/A	Clear Space to XWalk (in)	N/A
N/A	Any Obstructions?	N/A	N/A	Storm Grate/Utility Hazard?	N/A
	Obstruction Type			Storm Grate/Utility Type	
		N/A			N/A
			Yes	Surface Condition? (G/P)	Good

Remove & Replace Entire Ramp.
