# Access Compliance Report

## Public Rights-of-Way

### (Curb Ramps)

| Intersection ID: 10037289 | Main Street: SARDIS_RD_NORTH | Cross Street: N/A | Location: E |

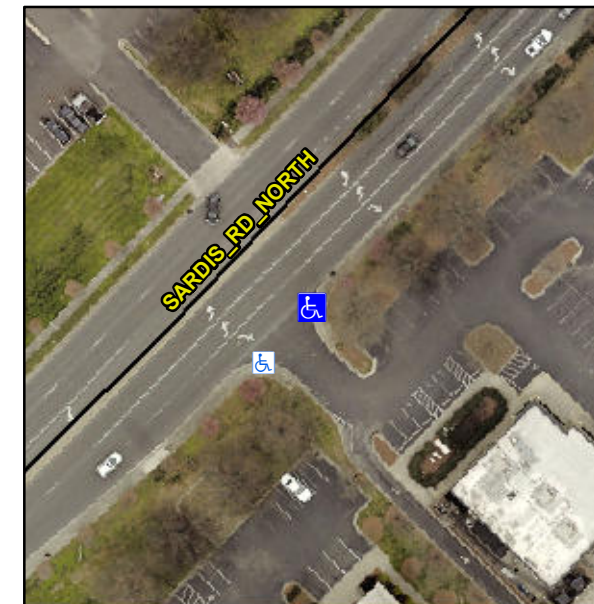
**Not Found, R304.5.3**

| Compliance | Description | Data | Compliance | Description | Data |
|---|---|---|---|---|---|
| N/A | Ramp Length (in) | 55.0 | Yes | Ramp Slope (%) | 8.0 |
| Yes | Ramp Width (in) | 48.0 | No | Ramp XSlope (%) | 5.4 |

**Remove & Replace Entire Ramp.**

Total Cost: \$ 1850.00
