## Access Compliance Report Public Rights-of-Way (Curb Ramps)

Intersection ID: 8723 Main Street: GLORY\_ST Cross Street: W\_CRAIGHEAD\_RD Location: SE

ADA ID: 7C6B358057EA Ramp Type: Para Initial Pass/Fail: Fail Overall Compliance: No Severity Score: 8.75

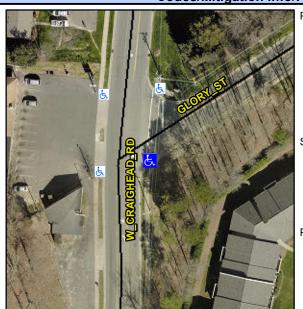
CURB GAP 2.0, LT RP < 5%

Compliance Description		Data	Compliance Description		Data
N/A	Ramp Length LT (in)	64.5	N/A	Ramp Length RT (in)	58.0
Yes	Ramp Width LT (in)	48.0	No	Ramp Width RT (in)	47.5
Yes	Ramp Slope LT (%)	2.1	Yes	Ramp Slope RT (%)	6.9
Yes	Ramp XSlope LT (%)	1.1	Yes	Ramp XSlope RT (%)	0.8
N/A	Landing Length (in)	N/A	N/A	DWS Provided?	N/A
N/A	Landing Width (in)	N/A	N/A	DWS Contrast?	N/A
N/A	Landing Slope (%)	N/A	N/A	DWS Length (in)	N/A
N/A	Landing X Slope (%)	N/A	N/A	DWS Full Width?	N/A
N/A	Landing Curb? (Y/N)	N/A	N/A	DWS Offset (in)	N/A
N/A	Shared Landing?	N/A			
N/A	Gutter Ponding?	N/A	N/A	Gutter Slope (%)	N/A
N/A	Gutter Lip Ht (in)	N/A	N/A	Gutter X Slope (%)	N/A
N/A	Painted X Walk1?	Yes	N/A	Painted X Walk2?	N/A
	X Walk 1 Direction	To N		X Walk 2 Direction	N/A
N/A	X Walk 1 Width (in)	95.0	N/A	X Walk 2 Width (in)	N/A
	X Walk 1 Slope (%)	0.2		X Walk 2 Slope (%)	N/A
	X Walk 1 X Slope (%)	2.0		X Walk 2 X Slope (%)	N/A
N/A	Ramp inside XWalk1?	Yes	N/A	Ramp inside XWalk2?	N/A

Road Slope (%)	N/A	N/A	Clear Space?	N/A
	Road X Slope (%)	N/A	N/A	Clear Space to XWalk (in)	N/A
N/A	Any Obstructions?	N/A	N/A	Storm Grate/Utility Hazard?	N/A
	Obstruction Type			Storm Grate/Utility Type	
		N/A			N/A
			Yes	Surface Condition? (G/P)	Good
			N/A	Curb Slope (%)	14.1

Remove & Replace Entire Ramp.

R304.5.1
