# Access Compliance Report

## Public Rights-of-Way

### (Curb Ramps)

Intersection ID: 31478	Main Street: ALSTON_HILL_DR	Cross Street: ELISE_MARIE_DR	Location: S
ADA ID: 7C798E6059BD	Ramp Type: Perp	Initial Pass/Fail: Fail	Overall Compliance: No
Severity Score: 10			
Codes/Mitigation Info/Possible Solution		Field Measurements/Component Compliance

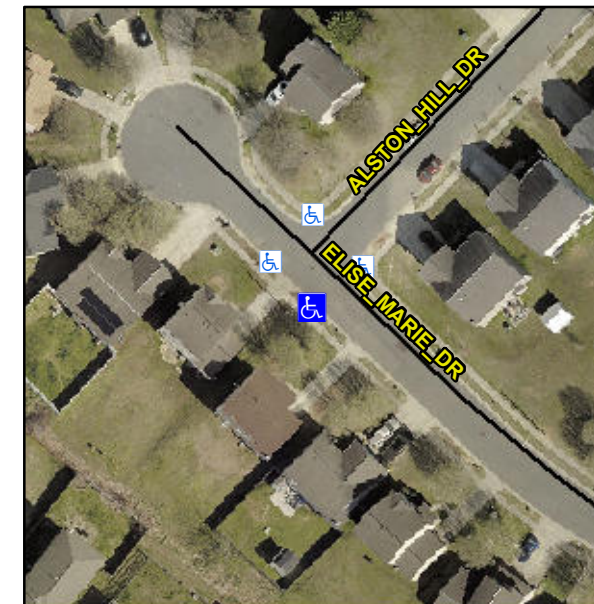
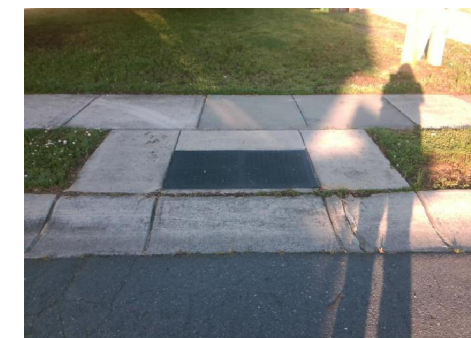
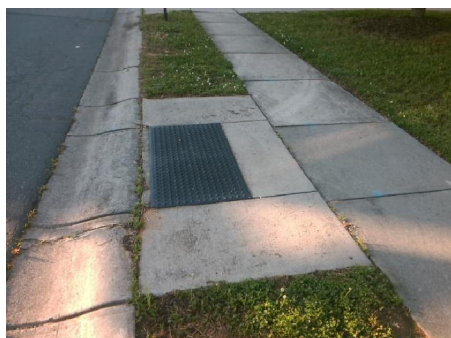
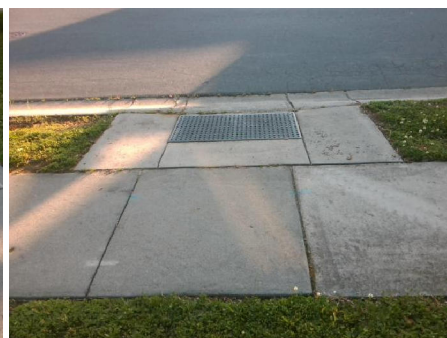
**Not Found, R304.5.1**

Compliance	Description	Data	Compliance	Description	Data
N/A	Ramp Length (in)	48.0	Yes	Ramp Slope (%)	5.6
No	Ramp Width (in)	47.5	Yes	Ramp XSlope (%)	3.4
N/A	Flare Type LT	N/A	N/A	Flare Type RT	N/A
N/A	Flare Slope LT (%)	N/A	N/A	Flare Slope RT (%)	N/A
N/A	Flare Traversable LT?	N/A	N/A	Flare Traversable RT?	N/A
N/A	Landing Length (in)	N/A	N/A	DWS Provided?	N/A
N/A	Landing Width (in)	N/A	N/A	DWS Contrast?	N/A
N/A	Landing Slope (%)	N/A	N/A	DWS Length (in)	N/A
N/A	Landing X Slope (%)	N/A	N/A	DWS Full Width?	N/A
N/A	Landing Curb? (Y/N)	N/A	N/A	DWS Offset (in)	N/A
N/A	Shared Landing?	N/A			
N/A	Gutter Ponding?	N/A	N/A	Gutter Slope (%)	N/A
N/A	Gutter Lip Ht (in)	0.5	N/A	Gutter X Slope (%)	N/A
N/A	Painted X Walk1?	No	N/A	Painted X Walk2?	N/A
	X Walk 1 Direction	To NE		X Walk 2 Direction	N/A
N/A	X Walk 1 Width (in)	N/A	N/A	X Walk 2 Width (in)	N/A
	X Walk 1 Slope (%)	0.3		X Walk 2 Slope (%)	N/A
	X Walk 1 X Slope (%)	3.7		X Walk 2 X Slope (%)	N/A

N/A	Ramp inside XWalk1?	N/A	N/A	Ramp inside XWalk2?	N/A
	Road Slope (%)	N/A	N/A	Clear Space?	N/A
	Road X Slope (%)	N/A	N/A	Clear Space to XWalk (in)	N/A
N/A	Any Obstructions?	N/A	N/A	Storm Grate/Utility Hazard?	N/A
	Obstruction Type			Storm Grate/Utility Type	
		N/A			N/A
			Yes	Surface Condition? (G/P)	Good

**Remove & Replace Entire Ramp.**
