Intersection ID: 30184	Main Street: BEATTIES_FORD_RD	Cross Street: SLATER_SPRINGS_DR	Location:	N
ADA ID: 7C7B54DB5251	Ramp Type: Perp	Initial Pass/Fail: Fail	Overall Compliance: No	Severity Score: 8.75

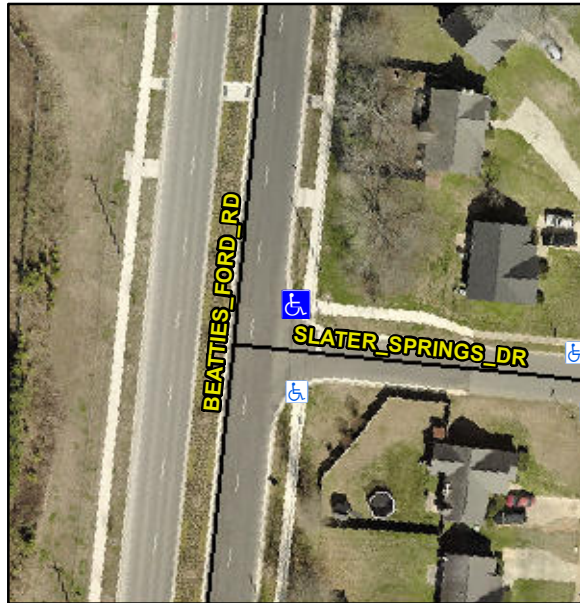
Possible Solutions:			Compliance	Description	Data	Compliance	Description	Data
<b>Remove &amp; Replace Entire Ramp.</b>			N/A	Ramp Length (in)	55.0	Yes	Ramp Slope (%)	7.0
			No	Ramp Width (in)	47.0	Yes	Ramp XSlope (%)	0.2
			N/A	Flare Type LT	N/A	N/A	Flare Type RT	N/A
			N/A	Flare Slope LT (%)	N/A	N/A	Flare Slope RT (%)	N/A
			N/A	Flare Traversable LT?	N/A	N/A	Flare Traversable RT?	N/A
			N/A	Landing Length (in)	N/A	N/A	DWS Provided?	N/A
			N/A	Landing Width (in)	N/A	N/A	DWS Contrast?	N/A
			N/A	Landing Slope (%)	N/A	N/A	DWS Length (in)	N/A
			N/A	Landing X Slope (%)	N/A	N/A	DWS Full Width?	N/A
			N/A	Landing Curb? (Y/N)	N/A	N/A	DWS Offset (in)	N/A
Surveyor Notes: <b>N/A</b>			N/A	Shared Landing?	N/A			
			N/A	Gutter Ponding?	N/A	N/A	Gutter Slope (%)	N/A
			N/A	Gutter Lip Ht (in)	N/A	N/A	Gutter X Slope (%)	N/A
			N/A	Painted X Walk1?	No	N/A	Painted X Walk2?	N/A
				X Walk 1 Direction	To S		X Walk 2 Direction	N/A

N/A	X Walk 1 Width (in)	N/A	N/A	X Walk 2 Width (in)	N/A
				X Walk 1 Slope (%)	1.3		X Walk 2 Slope (%)	N/A
				X Walk 1 X Slope (%)	1.7		X Walk 2 X Slope (%)	N/A
			N/A	Ramp inside XWalk1?	N/A	N/A	Ramp inside XWalk2?	N/A
				Road Slope (%)	N/A	N/A	Clear Space?	N/A
PROW/ADA: <b>Not Found, R304.5.1</b>				Road X Slope (%)	N/A	N/A	Clear Space to XWalk (in)	N/A
			N/A	Any Obstructions?	N/A	N/A	Storm Grate/Utility Hazard?	N/A
				Obstruction Type			Storm Grate/Utility Type	
					N/A			N/A
						Yes	Surface Condition? (G/P)	Good
Total Cost:			\$	1850.00

### Remove & Replace Entire Ramp.
