# Access Compliance Report

## Public Rights-of-Way

### (Curb Ramps)

Intersection ID: 52363	Main Street: DUNAVANT_ST	Cross Street: IRONSIDE_AV	Location: E
ADA ID: 7C8ACC38AA96	Ramp Type: Directional1	Initial Pass/Fail: Fail	Overall Compliance: No
		Severity Score: 12.5

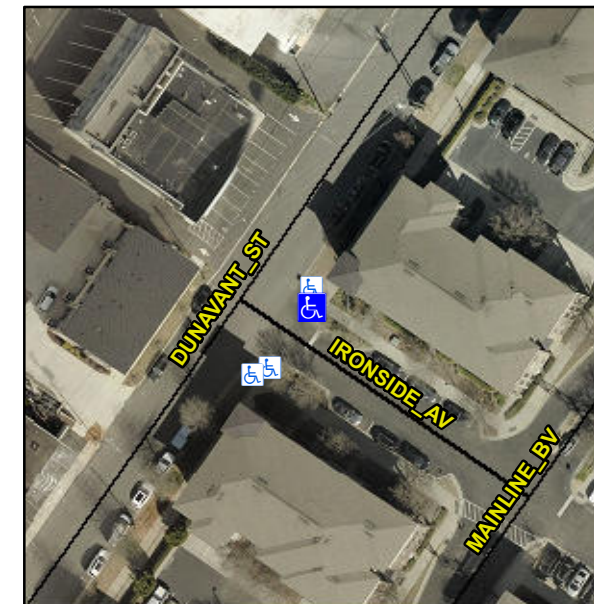
Compliance	Description	Data	Compliance	Description	Data
N/A	Ramp Length (in)	82.0	N/A	Grade Break?	N/A
Yes	Ramp Width (in)	96.0	N/A	Grade Break Slope (%)	0.0
Yes	Ramp Slope (%)	7.3	N/A	Grade Break XSlope (%)	0.0
No	Ramp XSlope (%)	5.3			
N/A	Flare Type LT	N/A	N/A	Flare Type RT	N/A
N/A	Flare Slope LT (%)	N/A	N/A	Flare Slope RT (%)	0.0
N/A	Flare Traversable LT?	N/A	N/A	Flare Traversable RT?	N/A
N/A	Landing Length (in)	0.0	N/A	DWS Provided?	N/A
N/A	Landing Width (in)	0.0	N/A	DWS Contrast?	N/A
N/A	Landing Slope (%)	0.0	N/A	DWS Length (in)	N/A
N/A	Landing X Slope (%)	0.0	N/A	DWS Full Width?	N/A
N/A	Landing Curb? (Y/N)	N/A	N/A	DWS Offset LT (in)	N/A
N/A	Shared Landing?	N/A	N/A	DWS Offset RT (in)	N/A
N/A	Gutter Ponding?	0.0	N/A	Gutter Slope (%)	N/A
N/A	Gutter Lip Ht (in)	0.0	N/A	Gutter X Slope (%)	N/A
N/A	Painted X Walk1?	No		Road Slope (%)	0.5
	X Walk 1 Direction	To SW		Road X Slope (%)	0.5
	X Walk 1 Width (in)	N/A		Clear Space?	N/A

X Walk 1 Slope (%)	0.5	N/A	Clear Space to XWalk (in)	N/A
	X Walk 1 X Slope (%)	0.5	N/A	Storm Grate/Utility Hazard?	N/A
N/A	Ramp inside XWalk1?	N/A		Storm Grate/Utility Type	
N/A	Any Obstructions?	N/A			N/A
	Obstruction Type		Yes	Surface Condition? (G/P)	Good
			N/A	Curb Slope (%)	5.7

Possible Solutions:

**Remove & Replace Entire Ramp.**
