# Access Compliance Report

## Public Rights-of-Way

### (Curb Ramps)

Intersection ID: 9668	Main Street: THE_PLAZA	Cross Street: VICKERY_DR	Location: SE
ADA ID: 7C8EB6170C7E	Ramp Type: Perp	Initial Pass/Fail: Fail	Overall Compliance: No
Severity Score: 13.75			
Codes/Mitigation Info/Possible Solution		Field Measurements/Component Compliance

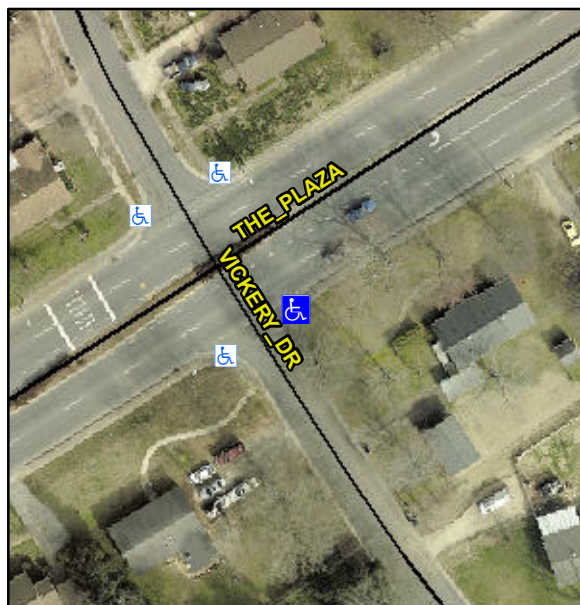
**Not Found, R304.2.2, R304.5.3**

Compliance	Description	Data	Compliance	Description	Data
N/A	Ramp Length (in)	60.5	No	Ramp Slope (%)	10.5
Yes	Ramp Width (in)	48.0	No	Ramp XSlope (%)	3.0
N/A	Flare Type LT	N/A	N/A	Flare Type RT	N/A
N/A	Flare Slope LT (%)	N/A	N/A	Flare Slope RT (%)	N/A
N/A	Flare Traversable LT?	N/A	N/A	Flare Traversable RT?	N/A
N/A	Landing Length (in)	N/A	N/A	DWS Provided?	N/A
N/A	Landing Width (in)	N/A	N/A	DWS Contrast?	N/A
N/A	Landing Slope (%)	N/A	N/A	DWS Length (in)	N/A
N/A	Landing X Slope (%)	N/A	N/A	DWS Full Width?	N/A
N/A	Landing Curb? (Y/N)	N/A	N/A	DWS Offset (in)	N/A
N/A	Shared Landing?	N/A			
N/A	Gutter Ponding?	Yes	N/A	Gutter Slope (%)	N/A
N/A	Gutter Lip Ht (in)	N/A	N/A	Gutter X Slope (%)	N/A
N/A	Painted X Walk1?	No	N/A	Painted X Walk2?	N/A
	X Walk 1 Direction	To SW		X Walk 2 Direction	N/A
N/A	X Walk 1 Width (in)	N/A	N/A	X Walk 2 Width (in)	N/A
	X Walk 1 Slope (%)	1.8		X Walk 2 Slope (%)	N/A
	X Walk 1 X Slope (%)	0.2		X Walk 2 X Slope (%)	N/A

**Remove & Replace Entire Ramp.**

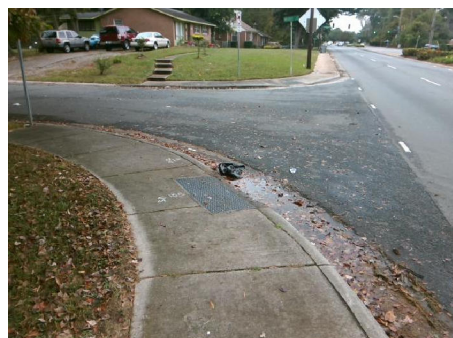
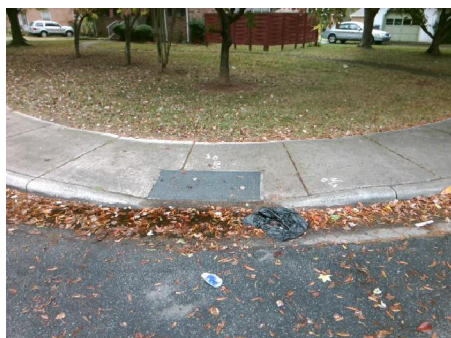
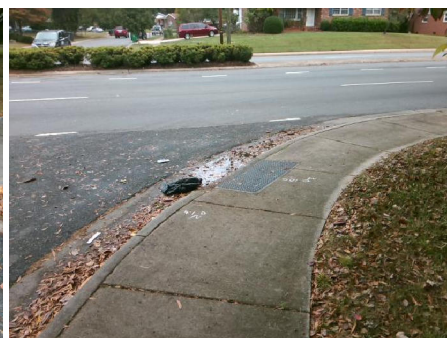
N/A	Ramp inside XWalk1?	N/A	N/A	Ramp inside XWalk2?	N/A
	Road Slope (%)	N/A	N/A	Clear Space?	N/A
	Road X Slope (%)	N/A	N/A	Clear Space to XWalk (in)	N/A
N/A	Any Obstructions?	N/A	N/A	Storm Grate/Utility Hazard?	N/A
	Obstruction Type			Storm Grate/Utility Type	
		N/A			N/A
			Yes	Surface Condition? (G/P)	Good
