Access Compliance Report Public Rights-of-Way (Curb Ramps)

Intersection ID: 2601Main Street:PROSPERITY_CHURCH_RDCross Street:EASTFIELD_RDLocation:NEADA ID: 7C99445F5A38Ramp Type:PerpInitial Pass/Fail:PassOverall Compliance:NoSeverity Score:0

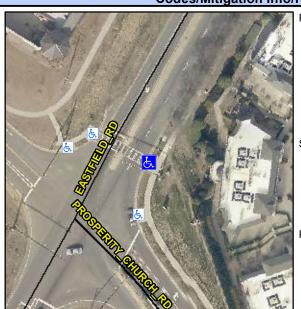
Street 1 Name EASTFIELD RD
Stop Condition-Street 2 Signal
Street 2 Name N/A
Stop Condition-Street 1 N/A

Yes
No
Yes
Yes
N/A
N/A
Yes
Yes
N/A
N/A

Possible Solutions:

Remove & Replace Landing.
