Access Compliance Report

Public Rights-of-Way

(Curb Ramps)

Intersection ID: 18797	Main Street: SENECA_PL	Cross Street: WEDGEWOOD_DR	Location: SE
ADA ID: 7C9BB16D9E23	Ramp Type: Perp	Initial Pass/Fail: Fail	Overall Compliance: No
		Severity Score: 12.5

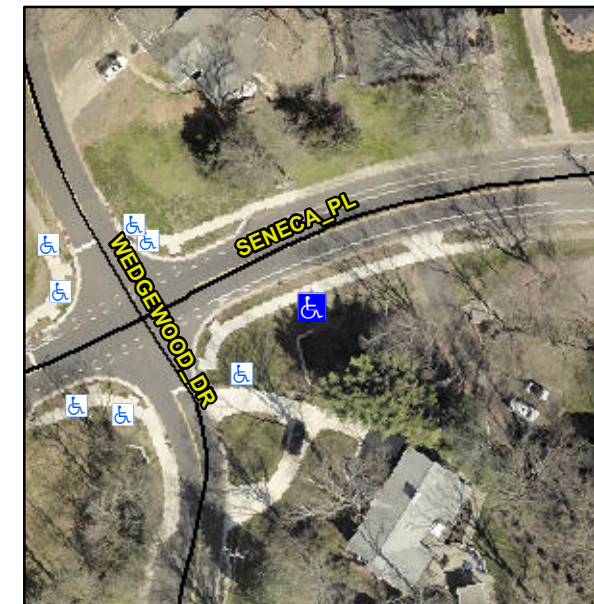
Compliance	Description	Data	Compliance	Description	Data
N/A	Ramp Length (in)	73.0	No	Ramp Slope (%)	9.4
Yes	Ramp Width (in)	74.0	Yes	Ramp XSlope (%)	1.4
N/A	Flare Type LT	N/A	N/A	Flare Type RT	N/A
N/A	Flare Slope LT (%)	N/A	N/A	Flare Slope RT (%)	N/A
N/A	Flare Traversable LT?	N/A	N/A	Flare Traversable RT?	N/A
N/A	Landing Length (in)	N/A	N/A	DWS Provided?	N/A
N/A	Landing Width (in)	N/A	N/A	DWS Contrast?	N/A
N/A	Landing Slope (%)	N/A	N/A	DWS Length (in)	N/A
N/A	Landing X Slope (%)	N/A	N/A	DWS Full Width?	N/A
N/A	Landing Curb? (Y/N)	N/A	N/A	DWS Offset (in)	N/A
N/A	Shared Landing?	N/A			
N/A	Gutter Ponding?	N/A	N/A	Gutter Slope (%)	N/A
N/A	Gutter Lip Ht (in)	N/A	N/A	Gutter X Slope (%)	N/A
N/A	Painted X Walk1?	No	N/A	Painted X Walk2?	N/A
	X Walk 1 Direction	To NW		X Walk 2 Direction	N/A
N/A	X Walk 1 Width (in)	N/A	N/A	X Walk 2 Width (in)	N/A
	X Walk 1 Slope (%)	2.4		X Walk 2 Slope (%)	N/A
	X Walk 1 X Slope (%)	1.3		X Walk 2 X Slope (%)	N/A

N/A	Ramp inside XWalk1?	N/A	N/A	Ramp inside XWalk2?	N/A
	Road Slope (%)	N/A	N/A	Clear Space?	N/A
	Road X Slope (%)	N/A	N/A	Clear Space to XWalk (in)	N/A
N/A	Any Obstructions?	N/A	N/A	Storm Grate/Utility Hazard?	N/A
	Obstruction Type			Storm Grate/Utility Type	
		N/A			N/A
			Yes	Surface Condition? (G/P)	Good

Possible Solutions:

Remove & Replace Entire Ramp.

R304.2.2
