Access Compliance Report

Public Rights-of-Way

(Curb Ramps)

Intersection ID: 44447	Main Street: REAMES_RD	Cross Street: BAYVIEW_PY	Location:	N
ADA ID: 7CC10E827054	Ramp Type: BlendTrans1	Initial Pass/Fail: Fail	Overall Compliance: No	Severity Score: 10

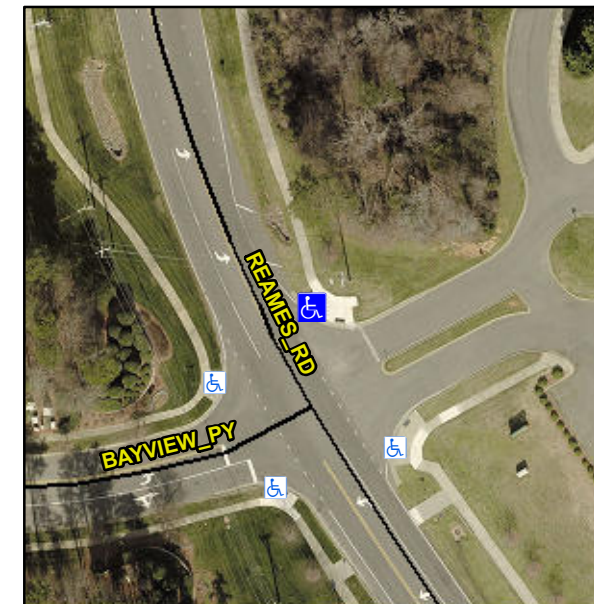
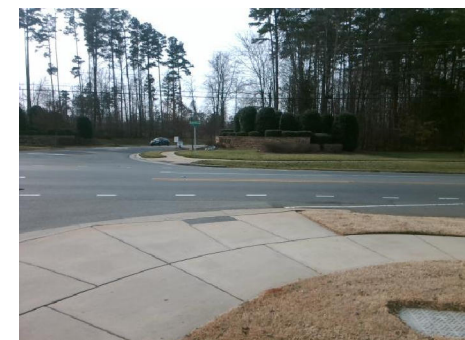
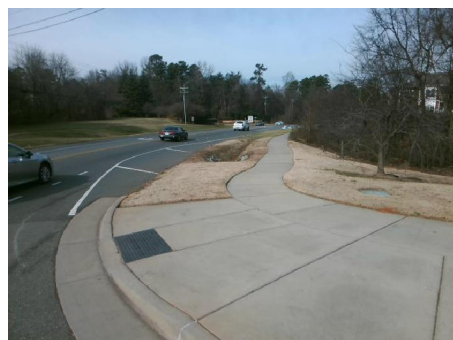
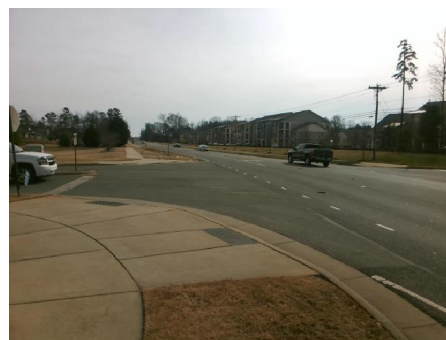
Not Found, R304.5.1, R304.5.3

Compliance	Description	Data	Compliance	Description	Data
N/A	Ramp Length (in)	103.0	Yes	BlendTrans Slope (%)	4.7
No	Ramp Width (in)	46.5	No	BlendTrans XSlope (%)	3.2
N/A	Flare Type LT	N/A	N/A	Flare Type RT	N/A
N/A	Flare Slope LT (%)	N/A	N/A	Flare Slope RT (%)	N/A
N/A	Flare Traversable LT?	N/A	N/A	Flare Traversable RT?	N/A
N/A	Landing Length (in)	N/A	N/A	DWS Provided?	N/A
N/A	Landing Width (in)	N/A	N/A	DWS Contrast?	N/A
N/A	Landing Slope (%)	N/A	N/A	DWS Length (in)	N/A
N/A	Landing X Slope (%)	N/A	N/A	DWS Full Width?	N/A
N/A	Landing Curb? (Y/N)	N/A	N/A	DWS Offset (in)	N/A
N/A	Shared Landing?	N/A			
N/A	Gutter Ponding?	N/A	N/A	Gutter Slope (%)	N/A
N/A	Gutter Lip Ht (in)	N/A	N/A	Gutter X Slope (%)	N/A
N/A	Painted X Walk1?	No	N/A	Painted X Walk2?	N/A
	X Walk 1 Direction	To SE		X Walk 2 Direction	N/A
	X Walk 1 Width (in)	N/A		X Walk 2 Width (in)	N/A
	X Walk 1 Slope (%)	4.9		X Walk 2 Slope (%)	N/A
	X Walk 1 X Slope (%)	1.4		X Walk 2 X Slope (%)	N/A

N/A	Ramp inside XWalk1?	N/A	N/A	Ramp inside XWalk2?	N/A
	Road Slope (%)	1.4		Clear Space?	N/A
	Road X Slope (%)	4.9	N/A	Clear Space to XWalk (in)	N/A
N/A	Any Obstructions?	N/A	N/A	Storm Grate/Utility Hazard?	N/A
	Obstruction Type			Storm Grate/Utility Type	
		N/A			N/A
			Yes	Surface Condition? (G/P)	Good
			No	Curb Slope (%)	18.7

Remove & Replace Curb Ramp With Two New Directional Ramps or Equivalent.
