Access Compliance Report

Public Rights-of-Way

(Curb Ramps)

Intersection ID: 31651	Main Street: MAZEN_CT	Cross Street: WILLIAM_REYNOLDS_DR	Location: NE
ADA ID: 7CCB517EF116	Ramp Type: PerpDiag	Initial Pass/Fail: Fail	Overall Compliance: No
Severity Score: 8.75			
Codes/Mitigation Info/Possible Solution		Field Measurements/Component Compliance

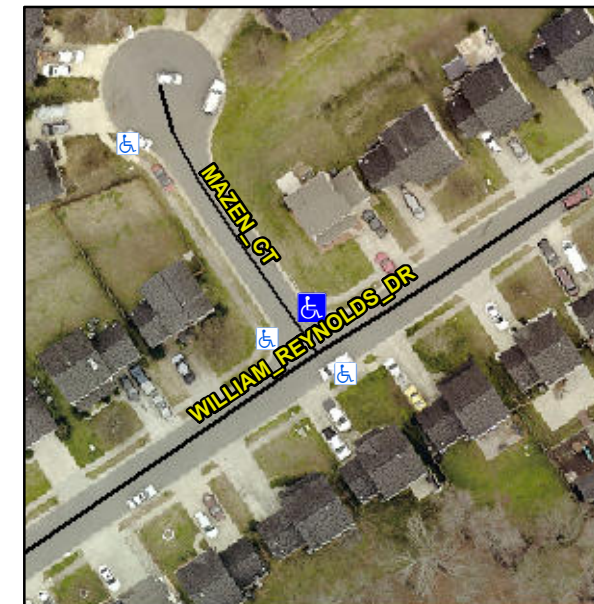
Not Found, R304.5.1

Compliance	Description	Data	Compliance	Description	Data
N/A	Ramp Length (in)	49.0	Yes	Ramp Slope (%)	6.0
No	Ramp Width (in)	47.5	Yes	Ramp XSlope (%)	1.0
N/A	Flare Type LT	N/A	N/A	Flare Type RT	N/A
N/A	Flare Slope LT (%)	N/A	N/A	Flare Slope RT (%)	N/A
N/A	Flare Traversable LT?	N/A	N/A	Flare Traversable RT?	N/A
N/A	Landing Length (in)	N/A	N/A	DWS Provided?	N/A
N/A	Landing Width (in)	N/A	N/A	DWS Contrast?	N/A
N/A	Landing Slope (%)	N/A	N/A	DWS Length (in)	N/A
N/A	Landing X Slope (%)	N/A	N/A	DWS Full Width?	N/A
N/A	Landing Curb? (Y/N)	N/A	N/A	DWS Offset (in)	N/A
N/A	Shared Landing?	N/A			
N/A	Gutter Ponding?	N/A	N/A	Gutter Slope (%)	N/A
N/A	Gutter Lip Ht (in)	N/A	N/A	Gutter X Slope (%)	N/A
N/A	Painted X Walk1?	No	N/A	Painted X Walk2?	No
	X Walk 1 Direction	To SW		X Walk 2 Direction	To SE
N/A	X Walk 1 Width (in)	N/A	N/A	X Walk 2 Width (in)	N/A
	X Walk 1 Slope (%)	0.9		X Walk 2 Slope (%)	0.1
	X Walk 1 X Slope (%)	1.7		X Walk 2 X Slope (%)	0.3

N/A	Ramp inside XWalk1?	N/A	N/A	Ramp inside XWalk2?	N/A
	Road Slope (%)	1.5	N/A	Clear Space?	N/A
	Road X Slope (%)	1.8	N/A	Clear Space to XWalk (in)	N/A
N/A	Any Obstructions?	N/A	N/A	Storm Grate/Utility Hazard?	N/A
	Obstruction Type			Storm Grate/Utility Type	
		N/A			N/A
			Yes	Surface Condition? (G/P)	Good

Possible Solutions:

Remove & Replace Curb Ramp With Two New Directional Ramps or Equivalent.
