# Access Compliance Report

## Public Rights-of-Way

### (Curb Ramps)

Intersection ID: 21497	Main Street: GREENWAY_VIEW_CT	Cross Street: WITHERS_MILL_DR	Location: W
ADA ID: 7CCC2D28FDE6	Ramp Type: BlendTrans2	Initial Pass/Fail: Fail	Overall Compliance: No
		Severity Score: 35

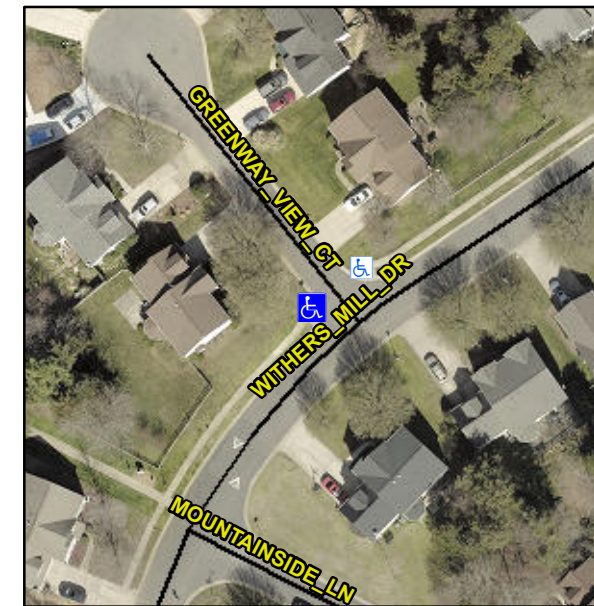
Compliance	Description	Data	Compliance	Description	Data
N/A	Ramp Length (in)	102.0	Yes	BlendTrans Slope (%)	4.2
No	Ramp Width (in)	24.0	Yes	BlendTrans XSlope (%)	1.2
N/A	Flare Type LT	N/A	N/A	Flare Type RT	N/A
N/A	Flare Slope LT (%)	N/A	N/A	Flare Slope RT (%)	N/A
N/A	Flare Traversable LT?	N/A	N/A	Flare Traversable RT?	N/A
N/A	Landing Length (in)	N/A	N/A	DWS Provided?	N/A
N/A	Landing Width (in)	N/A	N/A	DWS Contrast?	N/A
N/A	Landing Slope (%)	N/A	N/A	DWS Length (in)	N/A
N/A	Landing X Slope (%)	N/A	N/A	DWS Full Width?	N/A
N/A	Landing Curb? (Y/N)	N/A	N/A	DWS Offset (in)	N/A
N/A	Shared Landing?	N/A			
N/A	Gutter Ponding?	N/A	N/A	Gutter Slope (%)	N/A
N/A	Gutter Lip Ht (in)	N/A	N/A	Gutter X Slope (%)	N/A
N/A	Painted X Walk1?	No	N/A	Painted X Walk2?	No
	X Walk 1 Direction	To SE		X Walk 2 Direction	To NE
	X Walk 1 Width (in)	N/A		X Walk 2 Width (in)	N/A
	X Walk 1 Slope (%)	5.0		X Walk 2 Slope (%)	0.7
	X Walk 1 X Slope (%)	0.2		X Walk 2 X Slope (%)	0.8

N/A	Ramp inside XWalk1?	N/A	N/A	Ramp inside XWalk2?	N/A
	Road Slope (%)	2.6		Clear Space?	N/A
	Road X Slope (%)	0.8	N/A	Clear Space to XWalk (in)	N/A
N/A	Any Obstructions?	N/A	N/A	Storm Grate/Utility Hazard?	N/A
	Obstruction Type			Storm Grate/Utility Type	
		N/A			N/A
			Yes	Surface Condition? (G/P)	Good
			N/A	Curb Slope (%)	1.7

**Remove & Replace Curb Ramp With Two New Directional Ramps or Equivalent.**

**R304.5.1**
